CGKV Architects, Inc.

FEASIBILITY STUDY FOR THE ON-GOING USE OF WESTPORT MIDDLE SCHOOL

**400 OLD COUNTY ROAD
WESTPORT, MASSACHUSETTS**

SEPTEMBER 23, 2013

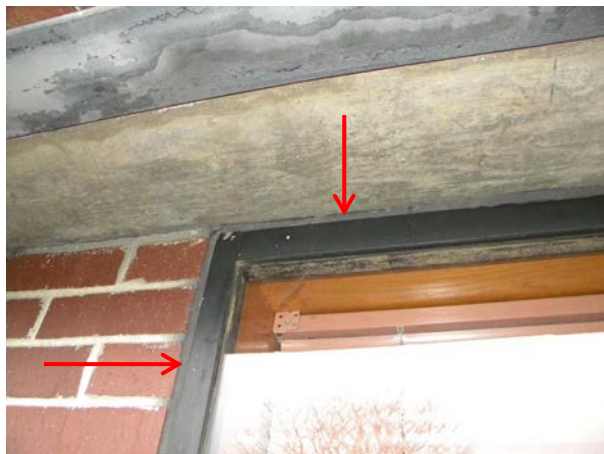
building interior. Some exterior window caulk had very high concentrations of PCBs, in the hundreds of thousands ppm in many cases. This caulk also contained asbestos. [Figure C-01]

Figure C-01: Exterior perimeter caulk at typical windows.

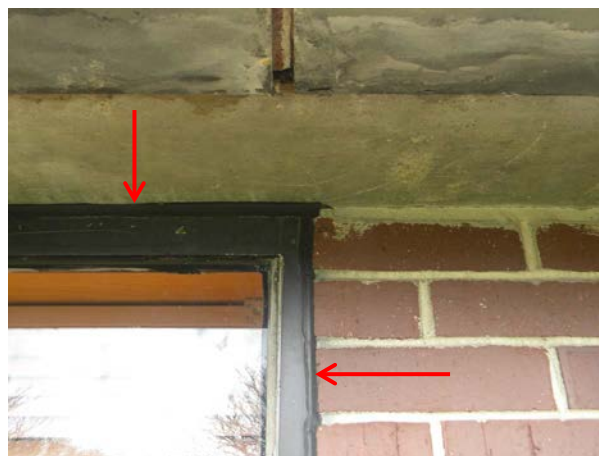
Figure C-03: Exterior perimeter caulk at typical windows removed and replaced.

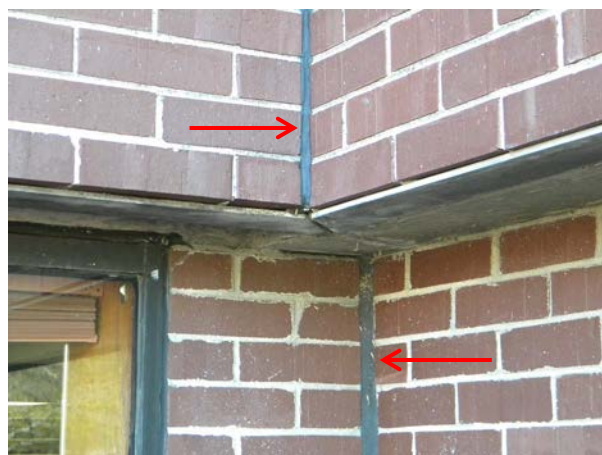
Figure C-09: Caulk at exterior expansion joints removed and replaced.

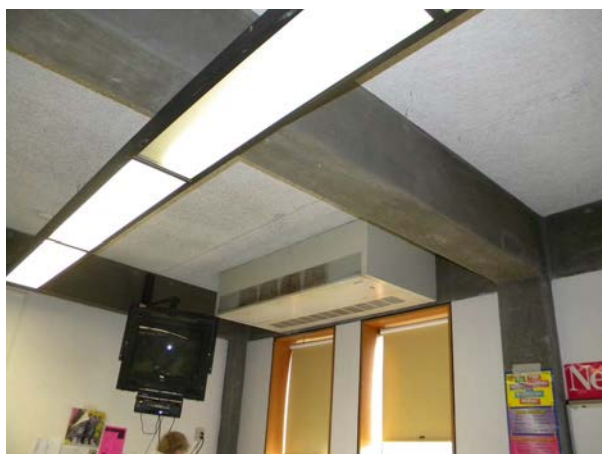
Tectum form plank panels are composed of wood fibers bonded and formed under heat and pressure. They were used as the underlying formwork for the placement of the cast-in-place concrete floor and roof slabs, and were left in place in many areas as a permanent part of the building construction to create a textured decorative ceiling finish that provides sound absorption, abuse resistance, and insulation. A mastic adhesive applied to the top surface of the Tectum form planks prior to concrete placement, possibly as a moisture barrier (though its actual purpose remains unclear), was found to contain PCBs and asbestos.

Figure C-12: Original Tectum form plank ceiling at typical classroom.

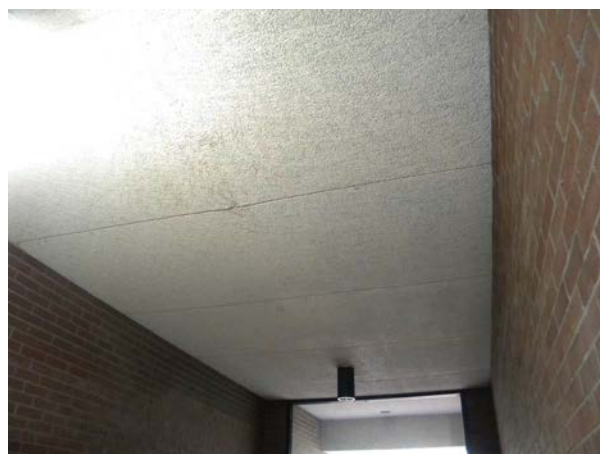
Figure C-13: Original Tectum form plank ceiling at typical stairway.

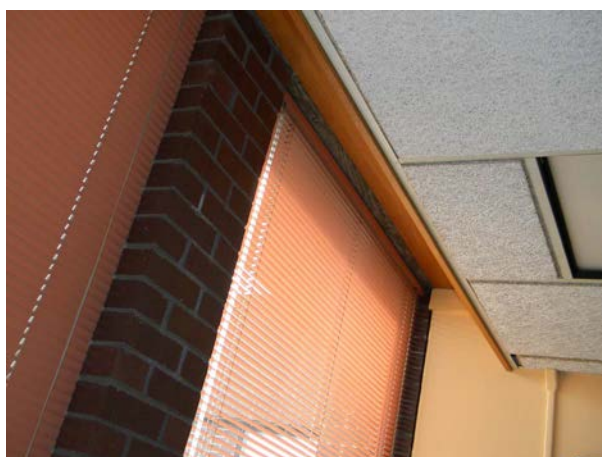
Figure C-14: Tectum lay-in acoustical ceiling panels in suspended metal grid at Main Administration area.

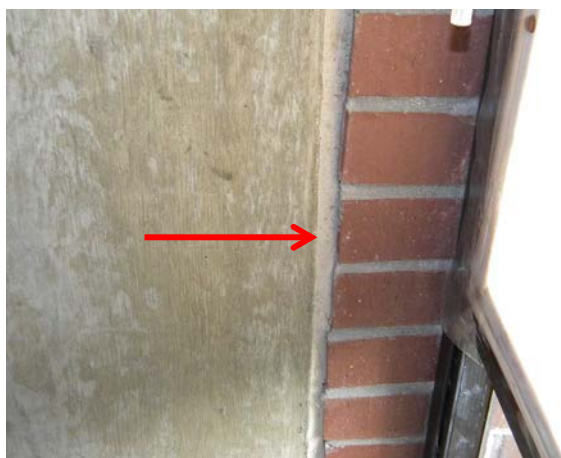
Figure C-23: Interior caulk at joint between cast-in-place concrete and brick.

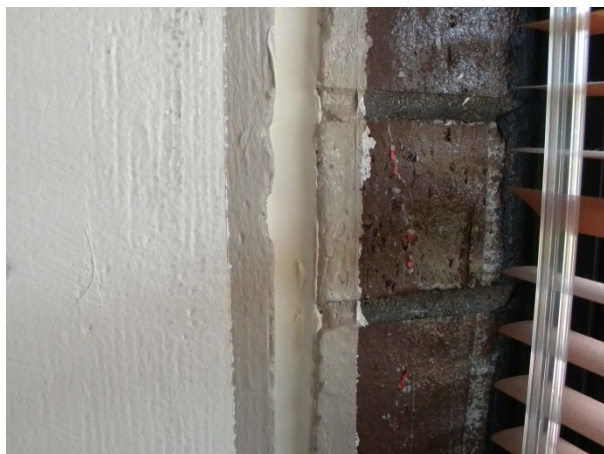
Figure C-26: Original interior caulk removed (and replaced) at joint between concrete column and brick pier.

Interior caulk at concrete structures to brick [Figure C-26], at interior expansion and control joints in masonry, and at interior metal door / fixed lite frames to masonry [Figure C-27] was removed. The remaining surfaces were cleaned and encapsulated with two coats of an epoxy coating. The joints were resealed with new silicone caulk (and backer rods where necessary).

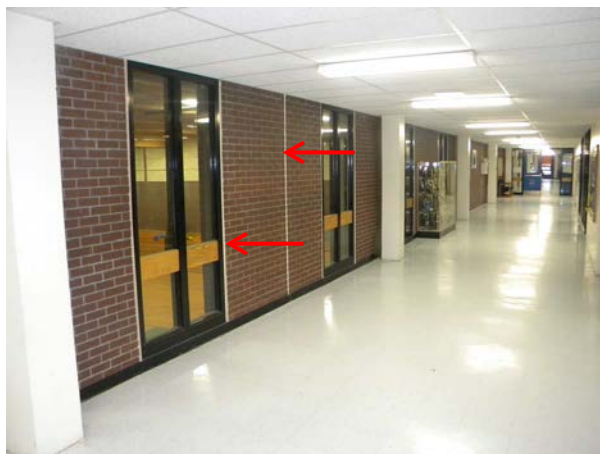
Figure C-27: Original interior caulk removed (and replaced) at expansion and control joints and at joints between steel frames and masonry.

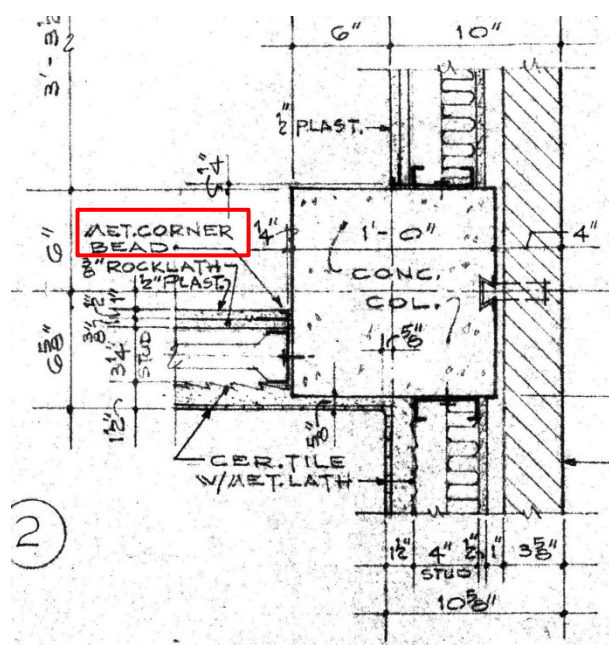
A foam filler found to contain PCBs may have served as a resilient joint to accommodate differential movement and to control cracking at plaster wall surfaces immediately adjacent to cast-in-place concrete columns and beams. The 1968 construction drawings typically called for a metal corner bead at such locations, and did not describe the foam filler observed and tested by EnviroScience. [Figure C-28]

Figure C-28: Typical details of joints between concrete structure and steel stud / plaster partitions called for metal corner bead, and did not describe the foam filler observed and tested by EnviroScience. [From 1968 Drawing A-19, Detail 2.]

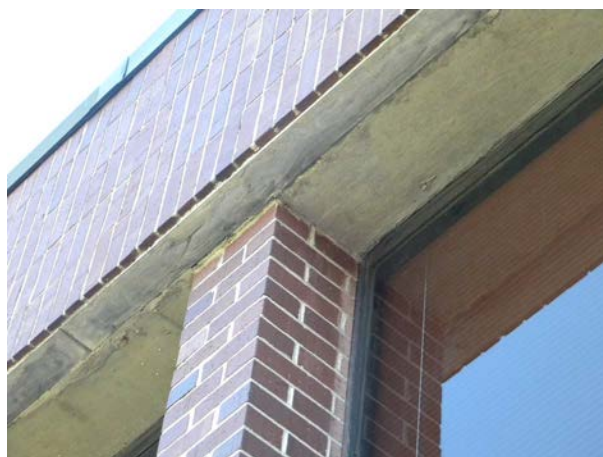
Exterior brick veneer at the perimeter of windows and doors immediately adjacent to exterior caulking known to be a Primary Source of PCBs was sampled at depths of 0" to 1/2" and 1/2" to 1". Tests indicated PCB concentration >1 ppm in brick at depths up to 1/2" to 1". Brick at interior caulk joints at exterior door frames was also found to have PCBs >1 ppm.

Exterior cast-in-place concrete beams and/or slabs serving as headers above windows and exterior doors were sampled at a depth of 0" to 1/2" and were found to have PCB concentrations >1 ppm in several locations.

Figure D-01: Brick veneer at typical window jambs and cast-in-place concrete beams at typical window heads.

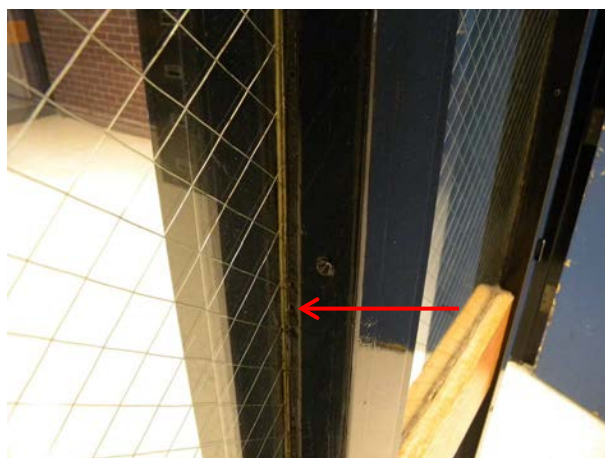
Steel-framed fixed lite interior sidelights and window walls are common throughout the building. These glass walls form partitions between related spaces and help the spread of daylight. Window walls are especially prevalent in the Main Administration area and in the Media Center. The glazing compound that helps seal the glass to the steel frame was found to contain PCBs in concentrations >1 ppm but <50 ppm.

Figure D-04: Interior glazing compound at fixed lite sidelights and window walls.

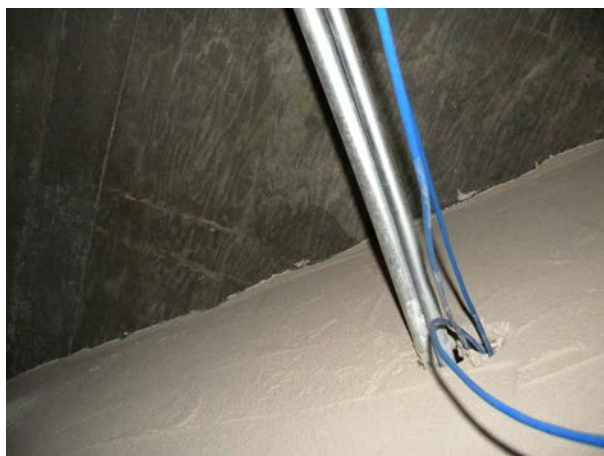
Bare concrete at columns and ceilings above suspended acoustical ceiling tiles in the Main Administration area were found to be contaminated with PCBs at >1 ppm.

This suggests that (1) typical cast-in-place concrete columns and beams likely absorbed PCBs through the air (or dust) and (2) even cast-in-place concrete floor and roof slabs constructed without the Tectum form planks (associated with mastics that are a known Primary Source of PCBs) are contaminated.

Figure D-05: Bare concrete slab without Tectum form plank above suspended ceiling areas.

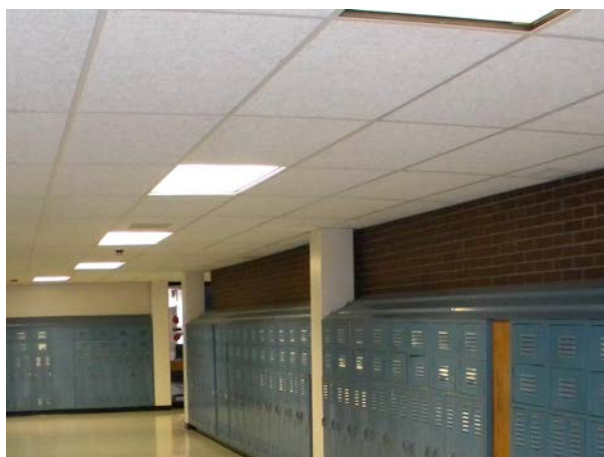
Tectum ceiling panels installed in a suspended metal grid are common to the building corridors as well as the Main Administration area, portions of the locker rooms, and portions of the Media Center. These ceiling tiles were tested and found to contain PCBs at >1 ppm. The absence of any identifiable mastic or coating at these tiles suggests that they were contaminated by PCBs in the air (or dust) over time.

Figure D-06: Tectum acoustical ceiling panels at typical corridor.

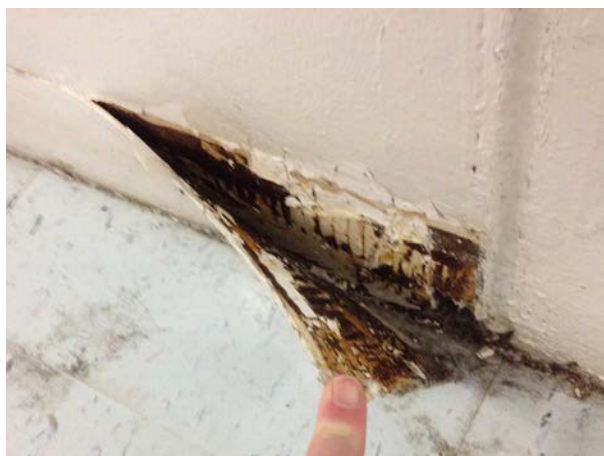
Mastic used to adhere resilient (vinyl or rubber) base to wall surfaces was found to contain PCBs >50 ppm. It is not clear whether this mastic is PCB Bulk Product Material or a contaminated PCB Remediation Waste.

Figure D-07: Resilient base mastic.

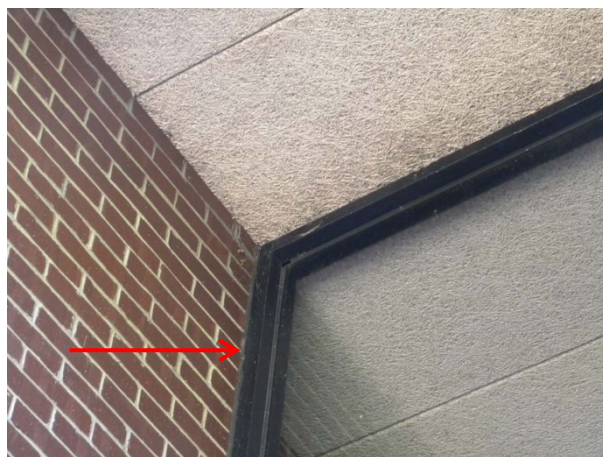
Figure G-01: Exterior PCB-containing caulk at door assemblies above 8'-0".

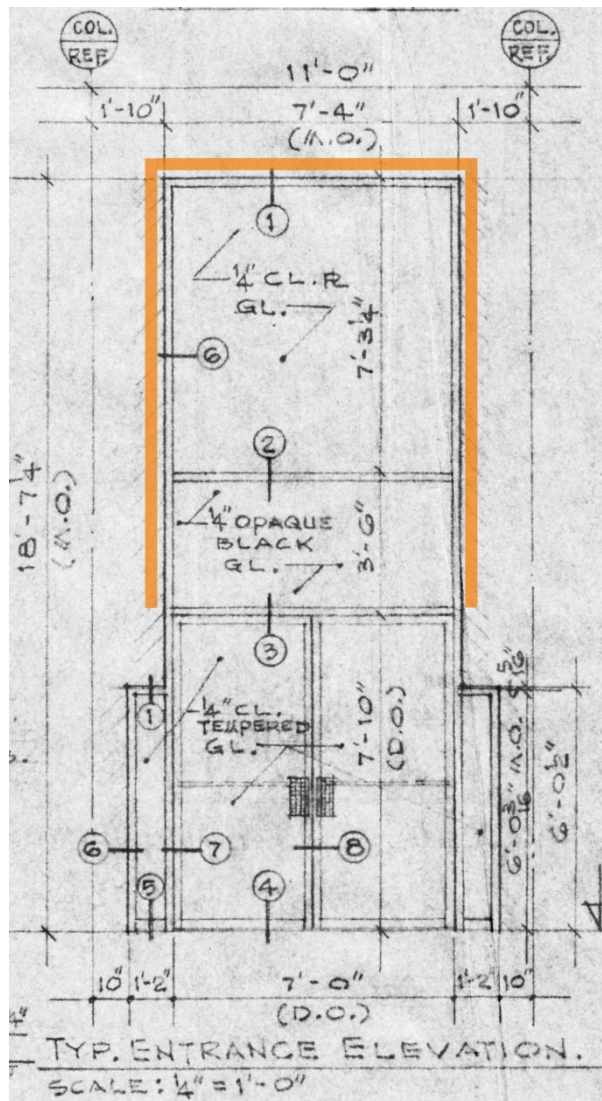
Figure G-02: Typical two-story exterior door assembly elevation. Orange lines indicate locations of exterior and interior caulk to be removed and replaced.

- a. There are five sets of **two-story height exterior door assemblies** (Doors Nos. 19, 30, 58, 81, & 100) [Figure G-02] exiting to grade from an intermediate level a few steps above the Lower Level.
 - i. Quantity: Remove, and subsequently replace, caulk at 5 exterior door assemblies x (28.5 LF exterior caulk + 28.5 LF interior caulk each) = approximately 285 LF total.
- b. There are two sets of **one-story exterior door assemblies** (Doors Nos. 52 & 75) [Figure G-03] exiting directly to grade from the Lower Level of the building. Interior suspended ceiling tiles at the one-story door assemblies must be removed and reinstalled to remove interior caulk.
 - i. Quantity: Remove, and subsequently replace, caulk at 2 exterior door assemblies x (14.5 LF exterior caulk + 14.5 LF interior caulk each) = approximately 58 LF total.

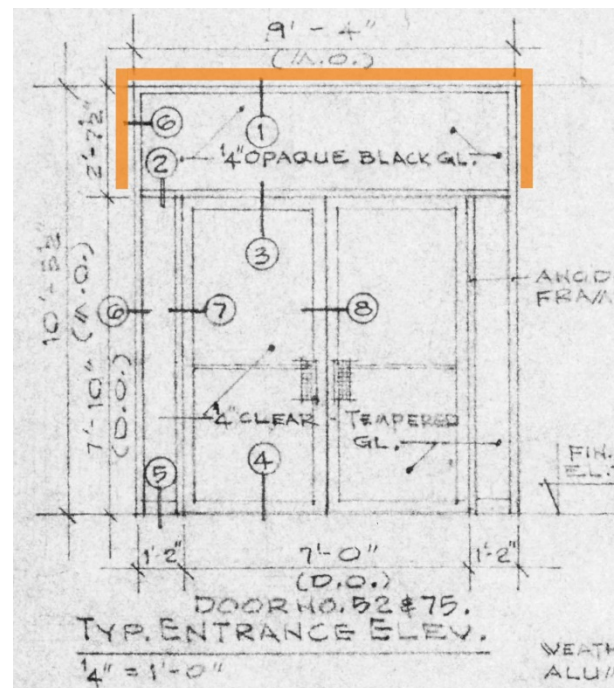
Figure G-03: Typical one-story exterior door assembly elevation. Orange lines indicate locations of exterior and interior caulk to be removed and replaced.

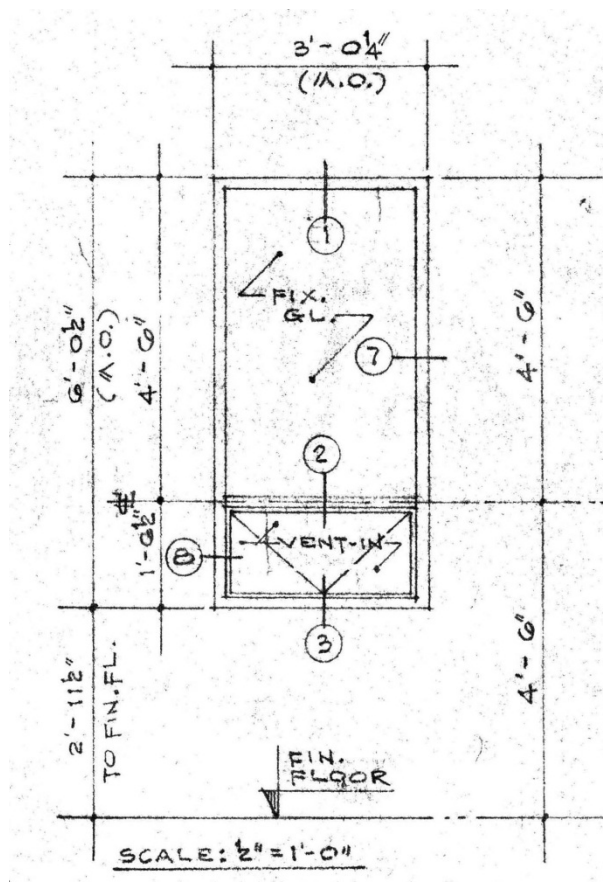
Figure G-06: Elevation of typical Type 'A/A1' window. [From 1968 Drawing A-20.]

Removed window systems should be replaced with new window systems, such as a 4.5" deep thermally-broken architectural grade aluminum window system with 1" thick insulated low E glass, in sizes, configurations, and operation (fixed and hopper) similar to the existing.

- a. **Type 'A/A1' windows** [Figure G-06] are of fixed over hopper configuration and are usually situated alone or in pairs in individual punched masonry openings. They are common at classrooms throughout the Lower and Upper Levels.
 - i. Quantity: Remove, and subsequently replace, 144 Type 'A/A1' windows x 18 SF each = approximately 2,592 SF total.
- b. **Type 'B' windows** [Figure G-07] are of fixed over hopper over fixed configuration and are usually arranged in long banks with brick piers separating individual masonry openings. Type B windows are located at the Main Administration area, the Media Center, the Cafeteria, the Art Room, and some classrooms, all at the Upper Level.
 - i. Quantity: Remove, and subsequently replace, 95 Type 'B' windows x 34 SF each = approximately 3,230 SF total.

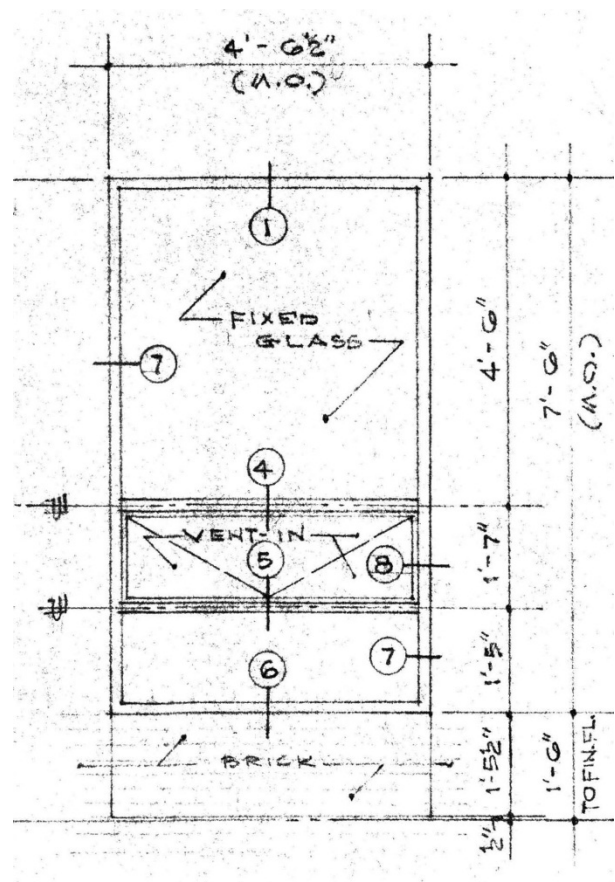
Figure G-07: Elevation of typical Type 'B' window. [From 1968 Drawing A-20.]

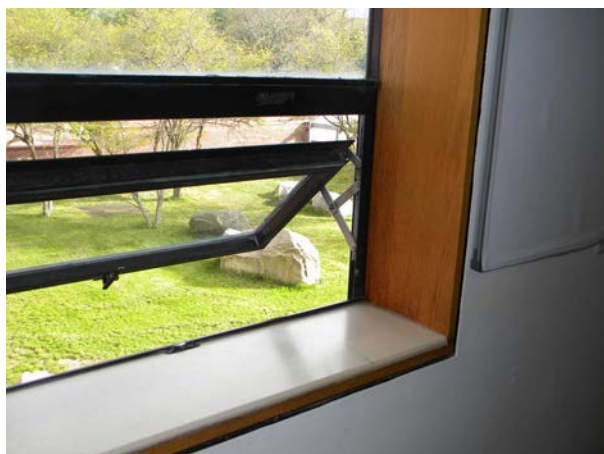
Figure G-08: Interior wood trim and Corian stools at typical Type 'A/A1' windows.

- c. Removal and replacement of the existing window systems should include the **interior wood and Corian trim** that surrounds typical Type 'A/A1' windows [Figure G-08]. The extent of possible contamination of this interior trim by PCBs, and its possible designation as PCB Remediation Waste, is presently unknown.
 - i. Quantity: Remove, and subsequently replace, interior wood trim (+/- 8.25" deep) and blocking at 144 Type 'A/A1' windows x 15 LF each = approximately 2,160 LF total.
 - ii. Quantity: Remove, and subsequently replace, interior Corian stools (+/- 8.25" deep) at 144 Type 'A/A1' windows x 3 LF each = approximately 432 LF total.

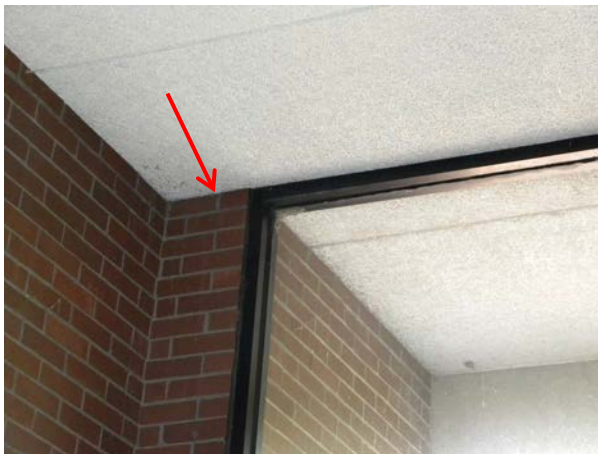
Figure G-09: Tectum form plank remaining at interior and exterior ceiling at stairways. Red arrow indicates 1'-0" step in brick veneer wall above which form plank extends.

- i. Quantity: Remove, and subsequently encapsulate, Tectum ceilings at 5 stairways x 300 SF of ceiling area each = approximately 1,500 SF of form plank and mastic removal total.
- ii. Quantity: Remove, and subsequently replace, brick veneer at 5 stairways x 3 courses x 33 LF (average) of veneer brick side wall x 2 walls each = approximately 330 LF total.

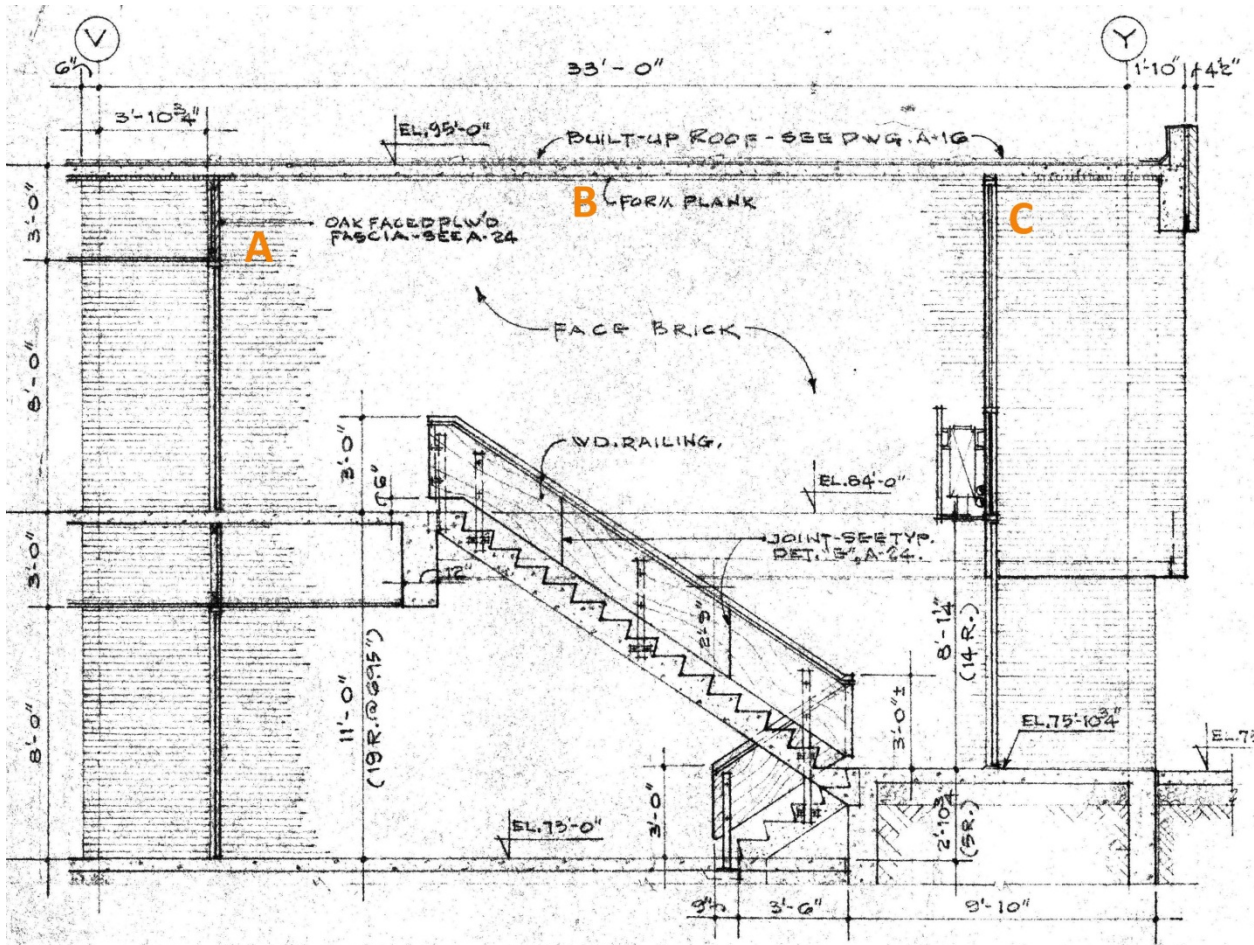
Figure G-13: Section through typical stairway. A = plywood fascia above door to corridor; B = Tectum form plank; C = exterior entrance assembly. [From 1968 Drawing A-23, Section 'A-A'.]

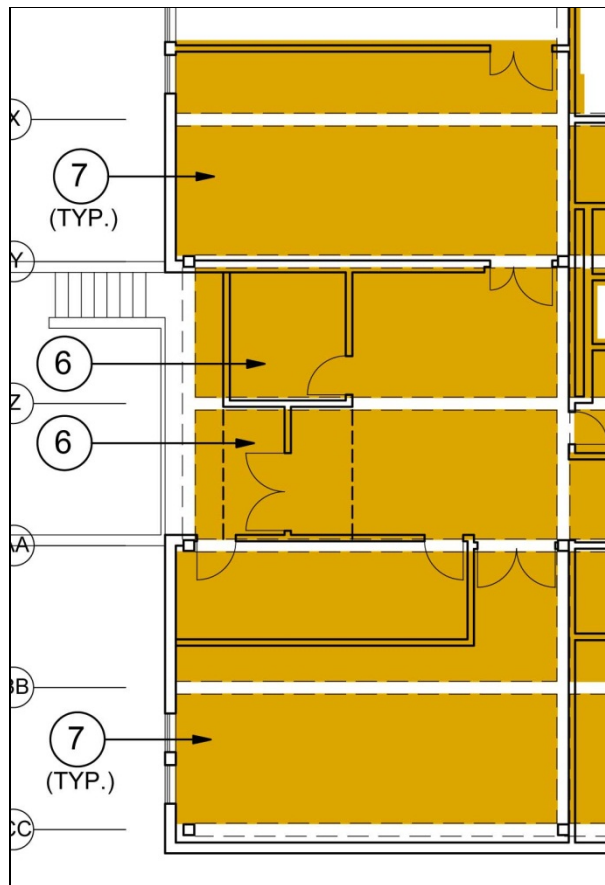
Figure G-14: Plan of receiving and custodial area. Areas in orange indicate existing Tectum form plank to be removed. 6 = areas of form plank to be removed above existing suspended ceilings; 7 = areas of existing exposed form plank.

- b. Tectum form plank and associated PCB-containing mastics must be removed in the vicinity of the **loading dock, storage area, custodial offices, and receiving area** at the southwest corner of the Upper Level. Tectum form plank is exposed to view and accessible at most of these spaces. An existing suspended ceiling must be removed and replaced in order to remove Tectum form plank at a portion of the receiving area and within the adjacent glass-enclosed office space. Following removal of the form plank, the PCB- (and asbestos-) containing mastics must be scraped and removed, and the remaining bare concrete ceiling must be encapsulated.
- i. Quantity: Remove Tectum form plank and subsequently encapsulate exposed concrete ceiling = approximately 1,600 SF total.
 - ii. Quantity: Remove, and subsequently replace, suspended ceiling system = approximately 230 SF total.

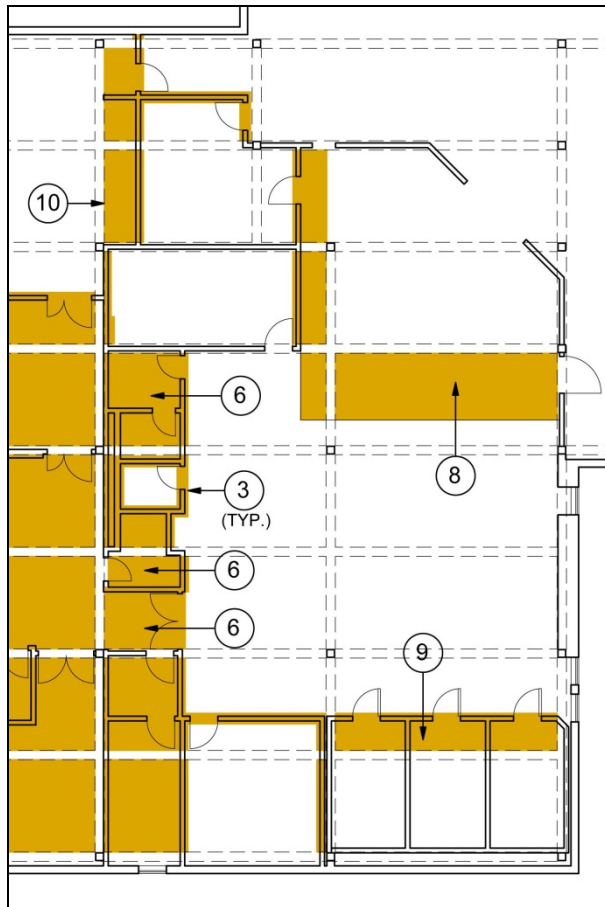
Figure G-15: Plan of kitchen area. Areas in orange indicate existing Tectum form plank to be removed. 3 = form plank to be removed from above partitions; 6 = areas of form plank to be removed above existing suspended ceilings at ancillary spaces; 8 = areas of form plank to be removed above existing soffit / suspended ceiling at serving area; 9 = areas of form plank to be removed above refrigerators and freezers; 10 = form plank to be removed from above soffit at Teacher Dining.

- iv. Quantity: Remove Tectum form plank, and subsequently encapsulate concrete, above refrigerators and freezers = approximately 100 SF total.

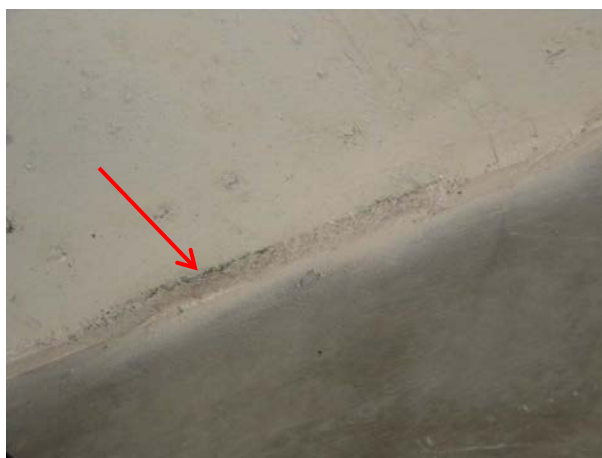
- j. CGKV observed some limited areas where portions of **Tectum form plank and associated mastics** were **not successfully completely removed** during the 2011 PCB Source Removal project. Remaining material was most commonly found in the slot that forms the intersection between concrete beams and concrete slabs. CGKV did not identify all such locations, so an allowance is used here for quantification.
- i. Quantity: Allowance for removal of Tectum form plank and associated mastic residue remaining from 2011 project = approximately 200 LF total.

Figure G-32: Portion of Tectum form plank and mastic not fully removed during 2011 project.

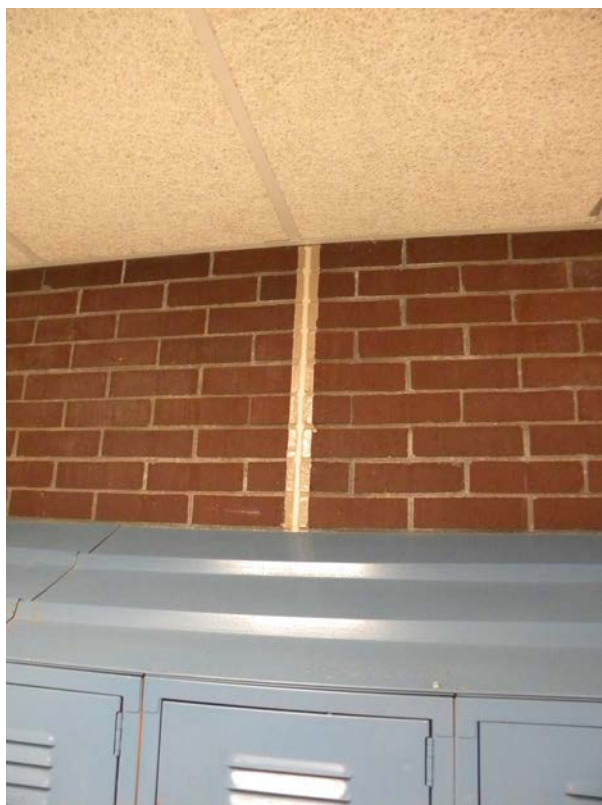
Figure G-33: Interior caulk at expansion / control joint in masonry wall is likely still in place behind the lockers.

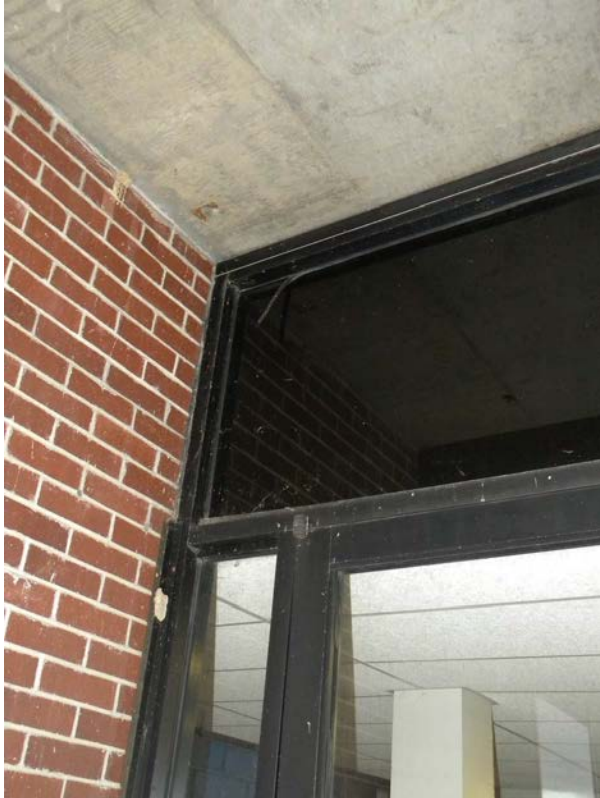
Figure H-09: Brick at jambs and concrete at head of one-story exterior door assembly.

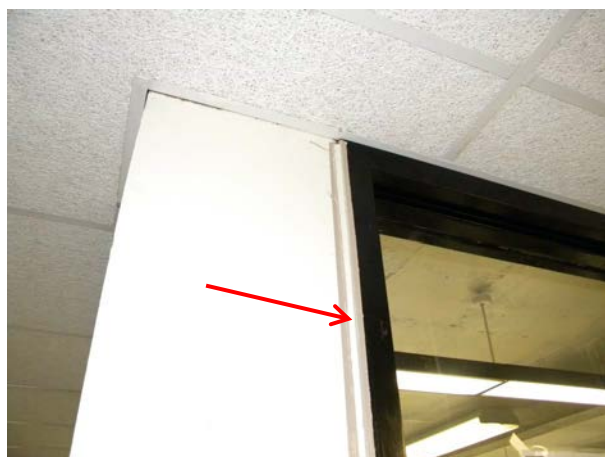
Figure H-23: Joint at steel frame to concrete.
(Note stripes of gray epoxy encapsulant at either side of existing joint applied in 2011.)

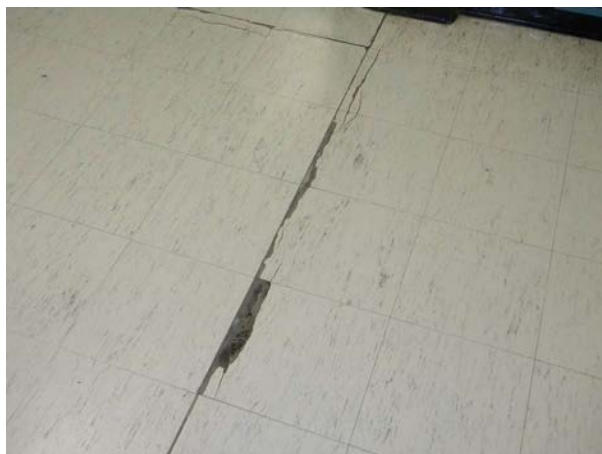
Figure H-35: Existing VCT / VAT; note wear.

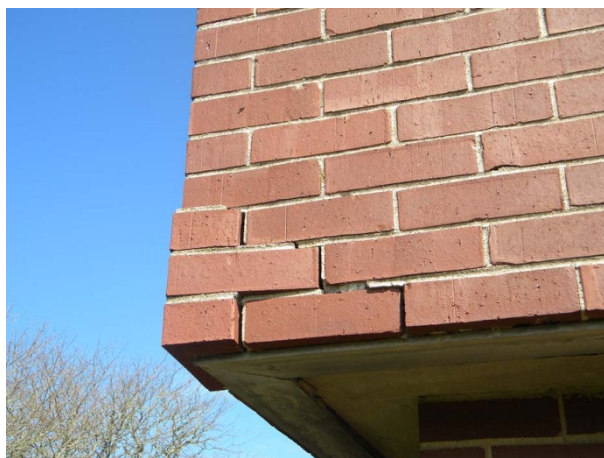
Figure I-01: Displaced brick veneer at outside corner.

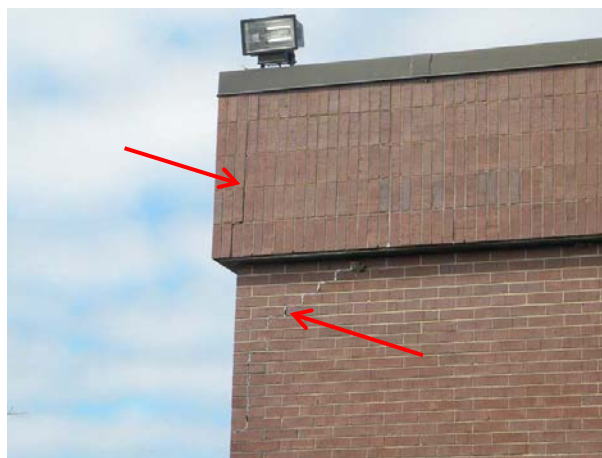
Figure I-02: Cracked joints and split brick at outside corner.

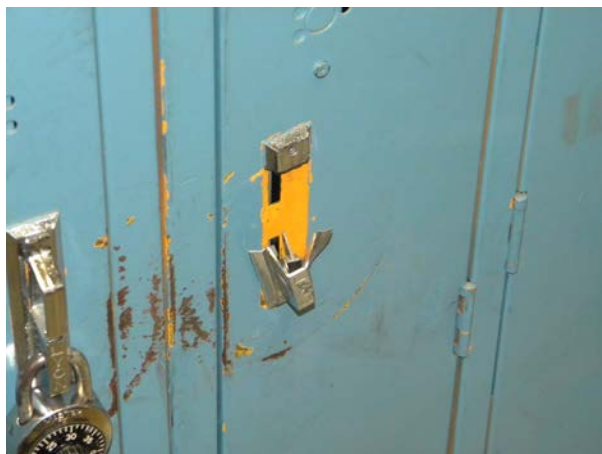
Figure I-04: Damaged original corridor lockers. Note that the original finish was subsequently painted over.

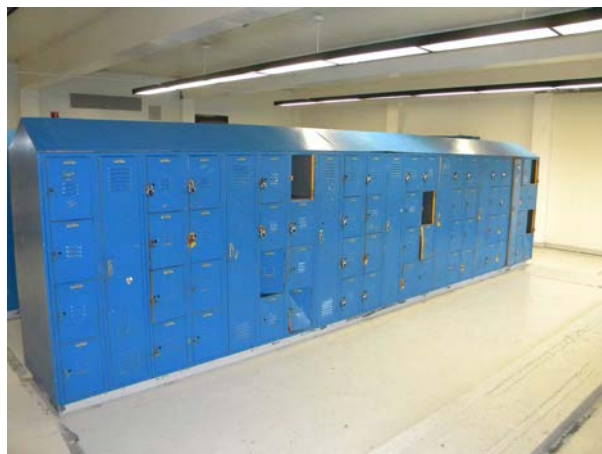
Figure I-05: Damaged original boys' locker room lockers, also repainted.

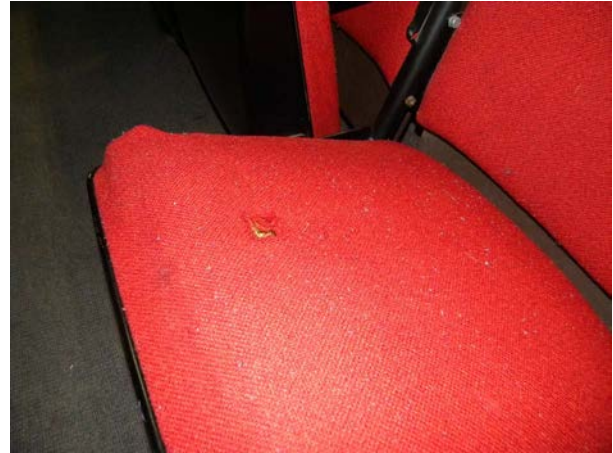
Figure I-07: Worn auditorium seating upholstery.

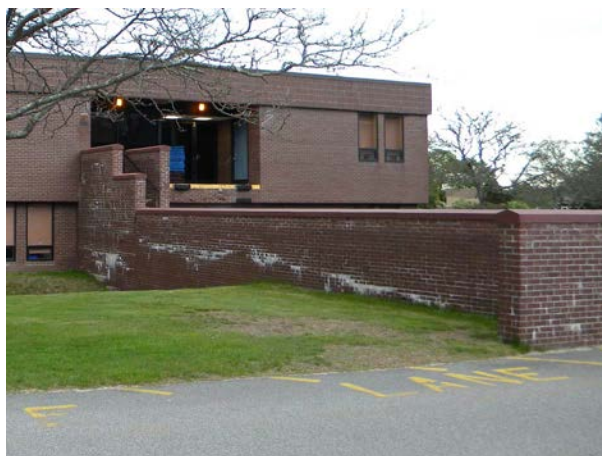
Figure I-08: Efflorescence at exterior brick walls to loading dock.
