CGKV Architects, Inc.

FEASIBILITY STUDY FOR THE ON-GOING USE OF WESTPORT MIDDLE SCHOOL

**400 OLD COUNTY ROAD
WESTPORT, MASSACHUSETTS**

SEPTEMBER 23, 2013

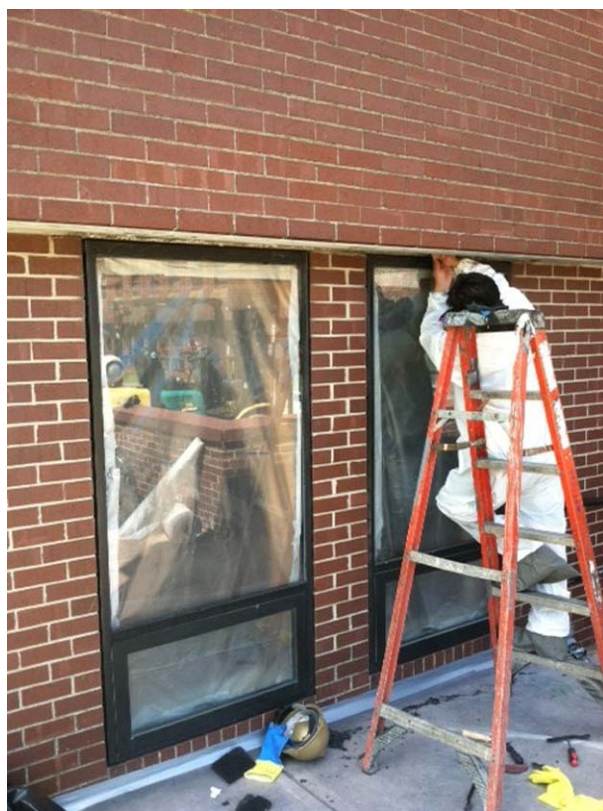
Figure C-02: Removal of exterior PCB-containing caulk at perimeter of windows. *[Photo courtesy of EnviroScience]*

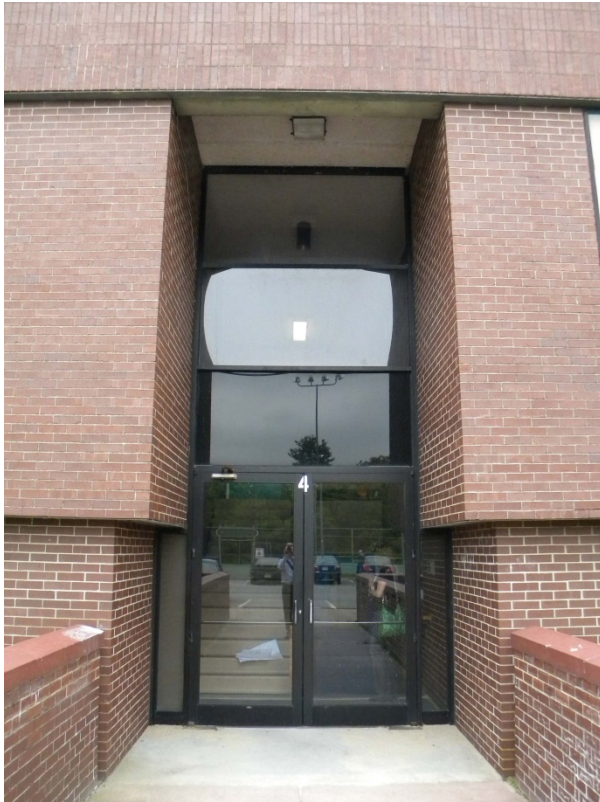
Figure C-04: Typical two-story exterior door assembly.

Removal of exterior and interior caulk at all exterior doors, including fixed glazing, above approximately 8'-0" is still required at all exterior door assemblies. See Section G.1, below.

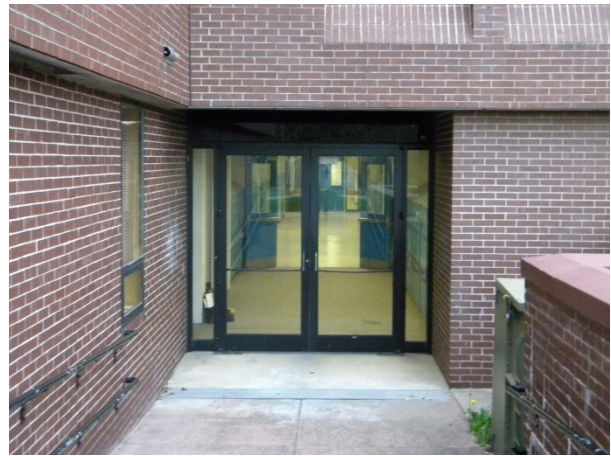
Figure C-05: Typical one-story exterior door assembly.

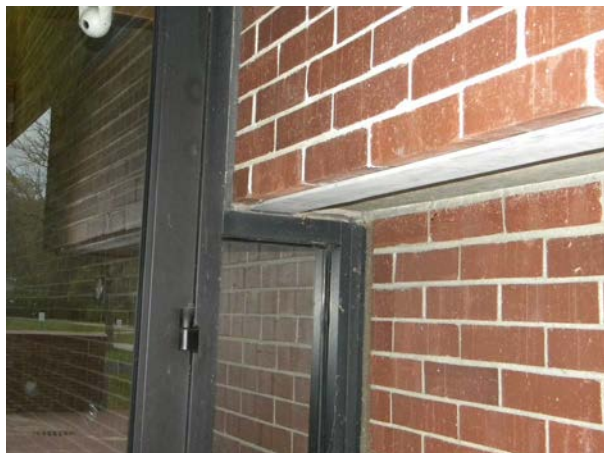
Figure C-06: Exterior caulk at perimeter of door frame. (Note: photo is from before 2011 removal project.)

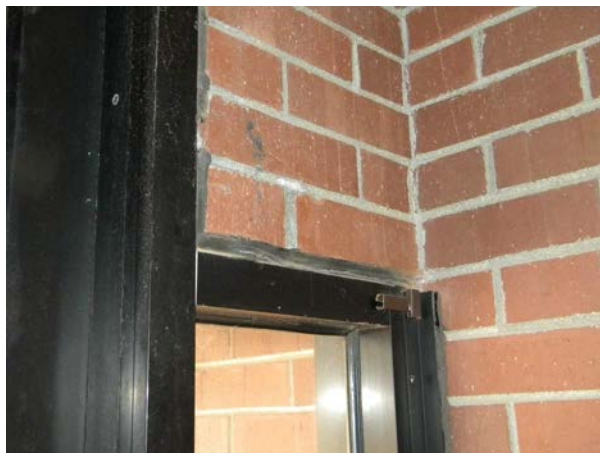
Figure C-07: Interior caulk at perimeter of door frame. (Note: photo is from before 2011 removal project.)

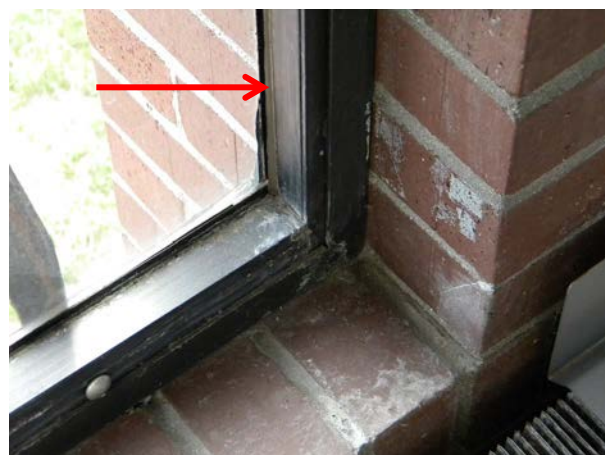
A PCB-containing glazing compound seals the interior edge of window glass to the fixed or operable metal window frames and sashes. This glazing compound also contains asbestos.

Figure C-10: Interior glazing compound at typical windows.

Removal of PCB-containing interior glazing compound at exterior windows will require removal of the complete window system, including glazing, metal sashes, and metal frames. See Section G.2, below.

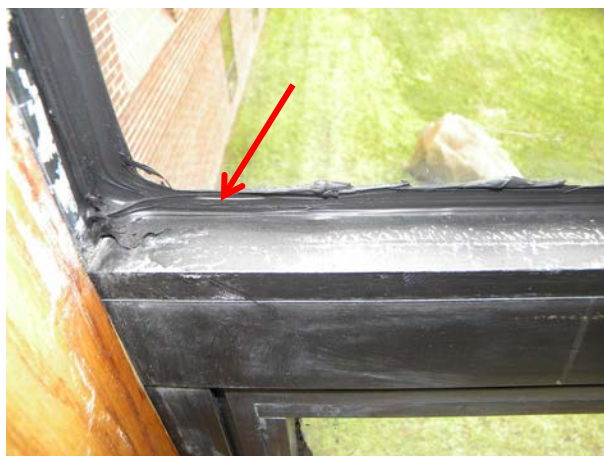
Removal of PCB source materials at interior glazing compounds at exterior metal windows was not practicable without replacement of the complete exterior window systems, so interior glazing compounds were left in place. Interim measures undertaken in 2011 included encapsulation of the existing interior glazing compound by applying a layer of new sealant over it. [Figure C-11]

Figure C-11: Sealant applied over interior glazing compound at typical windows as part of the 2011 removal project.

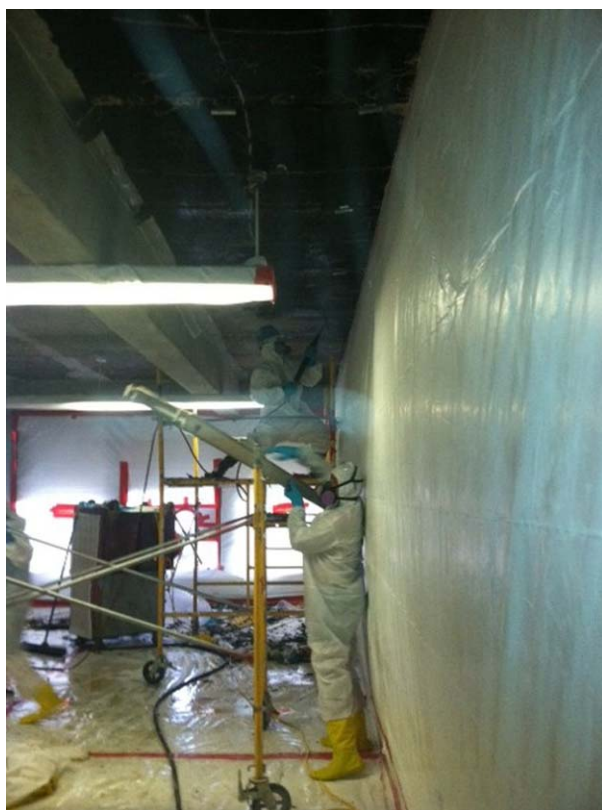
Figure C-16: Removal of existing Tectum form plank and associated PCB-containing mastic. [Photo courtesy of EnviroScience]

Tectum form planks located immediately below concrete floor and roof slabs were removed where exposed at classrooms, cafeteria, and media center. The remaining concrete ceilings were then scraped to remove the associated mastic which contained both PCBs and asbestos. Scraping and the use of mechanical chipping guns removed up to 95% of the mastic, and the concrete ceilings were then coated with a bridging encapsulant. [Figures C-16, C-17, C18]

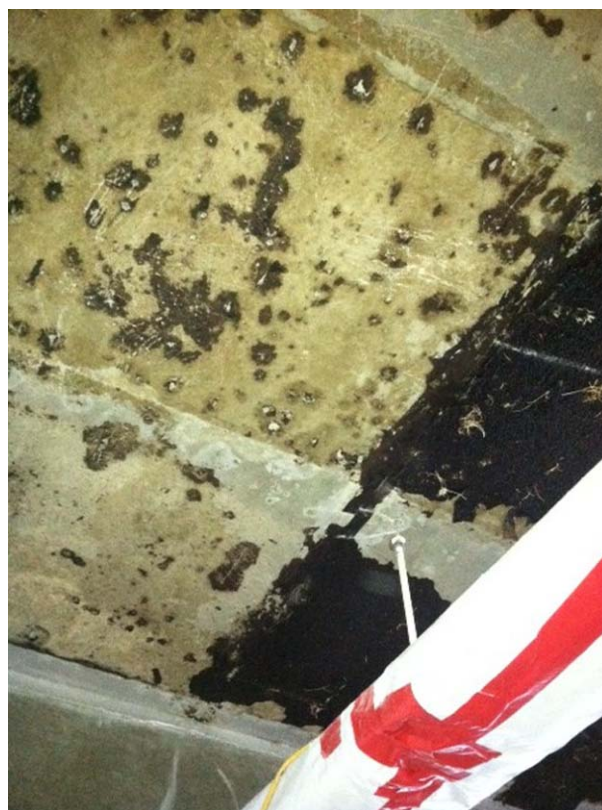
Figure C-17: PCB-containing mastic on cast-in-place concrete slabs, after removal of Tectum form plank. [Photo courtesy of EnviroScience]

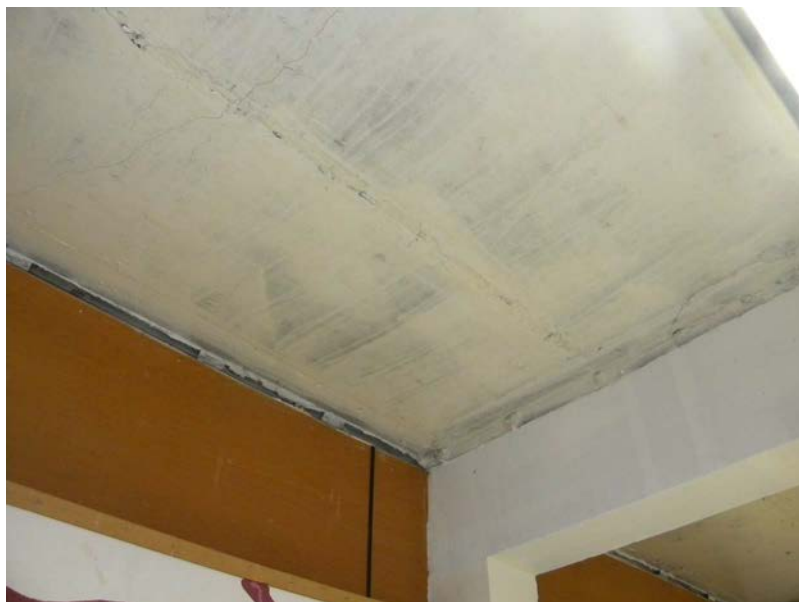
Figure C-18: Typical concrete slab, coated with bridging encapsulant, where Tectum form plank and associated mastics were removed.

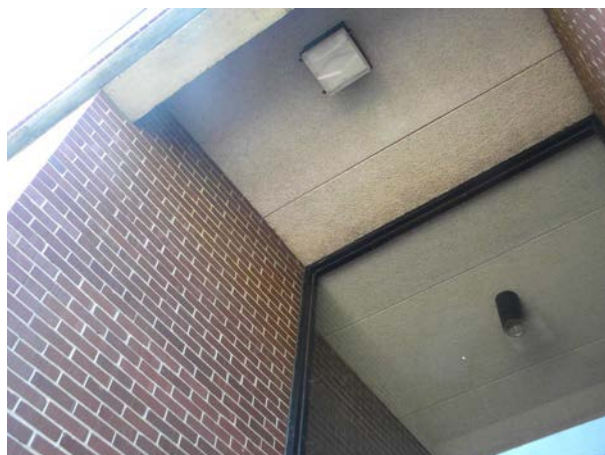
Some areas of Tectum form plank were not removed, including at stairways and exterior soffits at exterior doors [Figure C-19]. Tectum form plank was also not removed at the loading dock, storage area, custodial offices, portions of the kitchen area, and Lower Level storage room 153. Interior steel stud and plaster partitions were installed after installation of the Tectum form planks, and run full height to the underside of the Tectum; Tectum and mastic remain at the tops of nearly all these partitions [Figure C-20]. Ceiling mounted unit ventilators and other mechanical equipment were likewise installed directly underneath the Tectum form planks, and PCB Bulk Product Wastes remain at these locations [Figure C-21 and C-22]. Some areas of Tectum form plank also remain concealed above suspended ceilings. See Section G.3, below, for a complete description of remediation work remaining at Tectum form planks and associated mastics.

Figure C-19: Tectum form plank remaining at exterior and interior stairway / entrance ceilings.

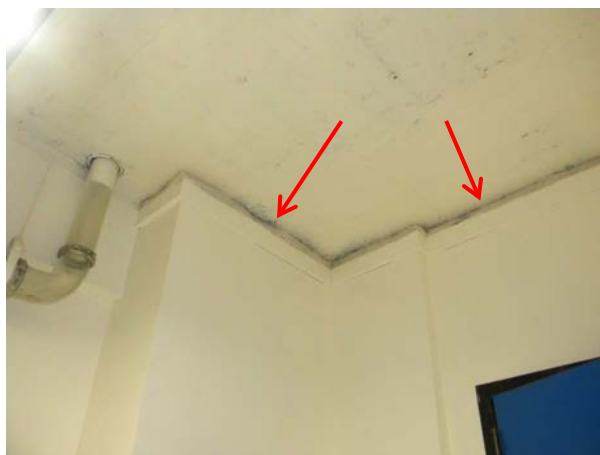
Figure C-20: Tectum form plank remaining at the tops of typical partitions.

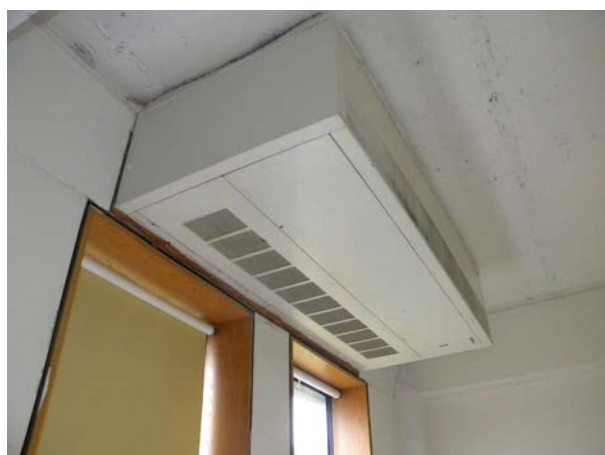
Figure C-21: Tectum form plank remaining above typical ceiling-mounted unit ventilators.

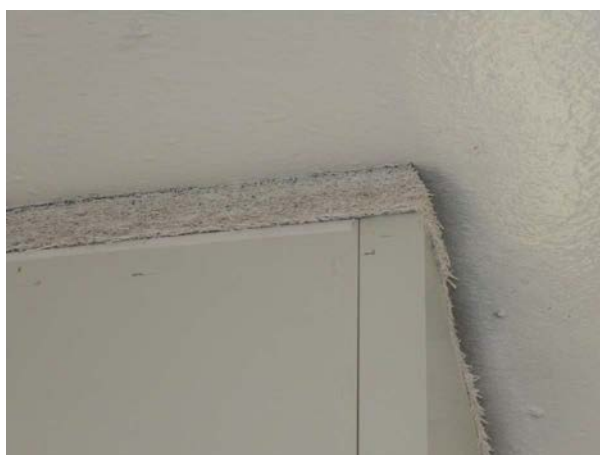
Figure C-22: Enlarged view of Tectum form plank above unit ventilators.

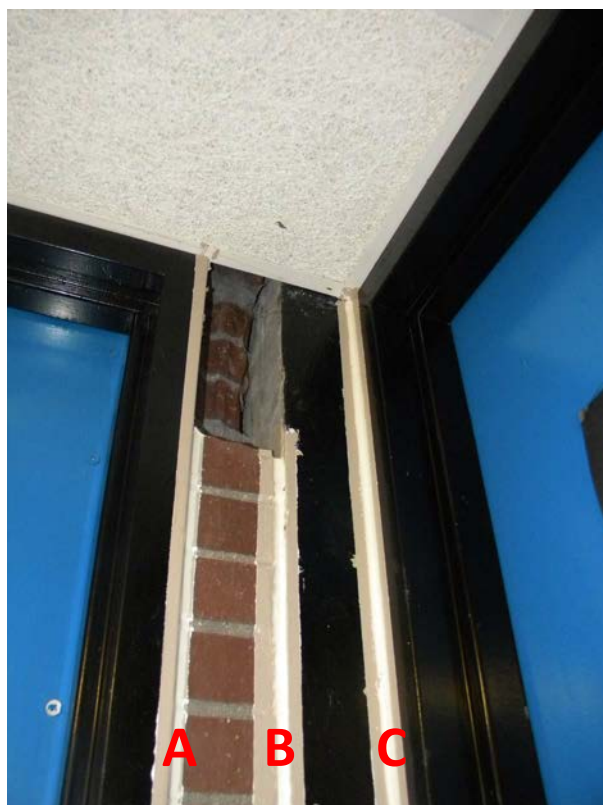
PCB-containing caulk was also identified at the joints between interior steel door / fixed lite frames and adjacent brick walls and concrete columns. This material is similar to that found at interior expansion / control joints and at joints between concrete and brick. [Figure C-25]

Figure C-25: Interior caulk joints at steel door frames to brick (A), brick to concrete (B), and concrete to steel door frames (C). (Note: this is a post-remediation photo.)

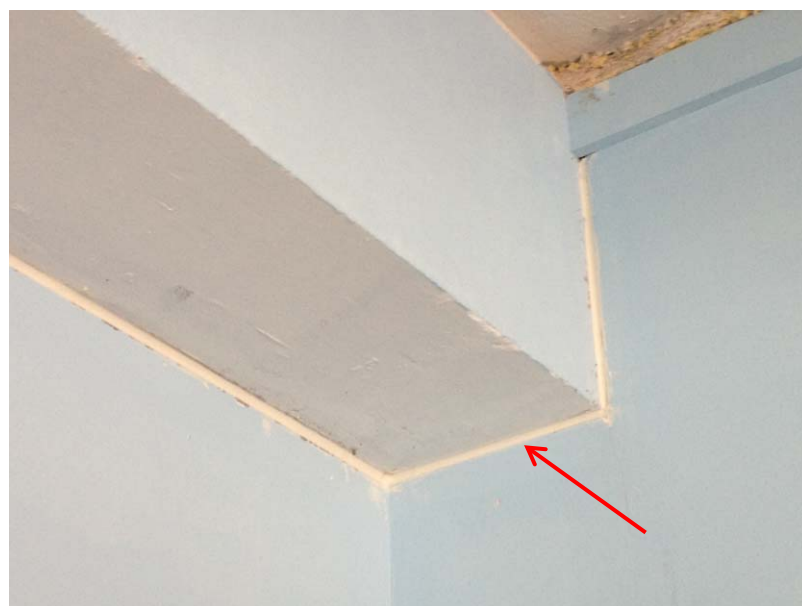
Figure C-29: Original foam filler removed at joints between concrete structure and plaster partitions. Joints cleaned out, encapsulated, and resealed with new caulk.

PCB-containing foam filler was removed at joints between interior concrete structures and plaster walls. The remaining surfaces were cleaned and encapsulated with two coats of an epoxy coating. The joints were resealed with new caulk (and backer rods where necessary). [Figure C-29]

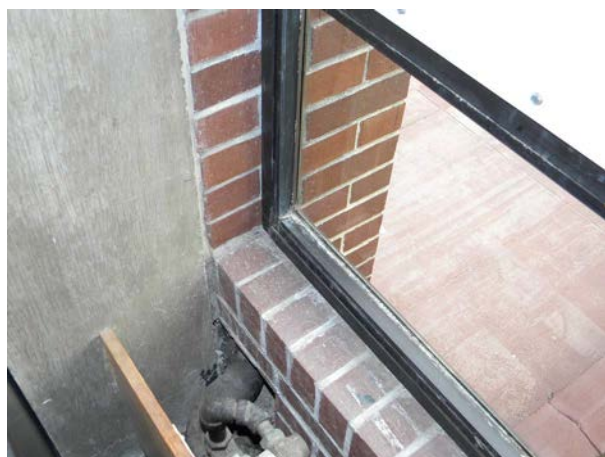
Figure D-02: Interior brick at typical window jambs and sills, and interior concrete at brick piers.

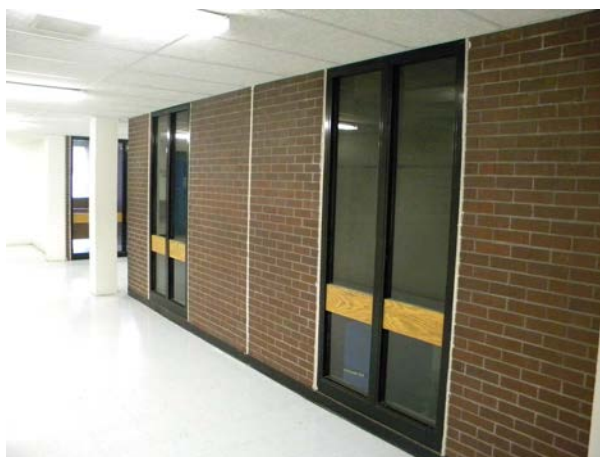
This is understood to include brick on either side of expansion / control joints at existing reinforced brick masonry walls at the perimeter of Gymnasium and Auditorium spaces as well as brick adjacent to caulked steel door and fixed lite frames. [Figure D-03]

Figure D-03: Interior brick adjacent to expansion / control joints and fixed lite frames.

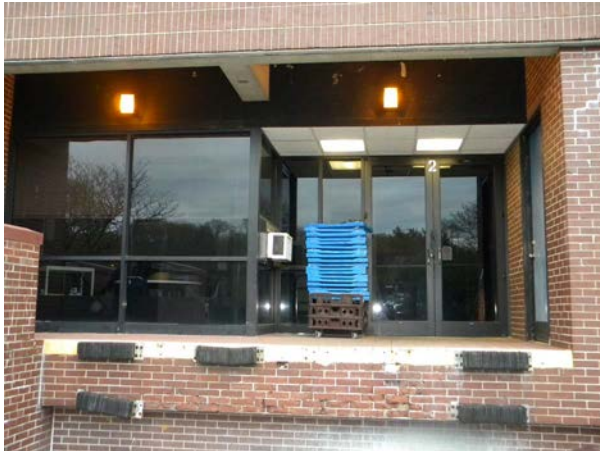
- c. There is also one **aluminum-framed glazed storefront assembly** (including Door No. 205) exiting from the receiving area at the Upper Level [Figures G-04 and G-05], with brick at the jambs and a plywood soffit assembly at the head. It is presumed that all perimeter caulk joints at the receiving area storefront (including at the soffit assembly) contain PCBs and must be removed, and that interior suspended ceiling tiles must be removed and reinstalled to remove interior caulk.

Figure G-04: Loading dock and receiving area.

- i. Quantity: Remove, and subsequently replace, caulk at 1 storefront assembly x (76 LF exterior caulk + 76 LF interior caulk) = approximately 152 LF total.

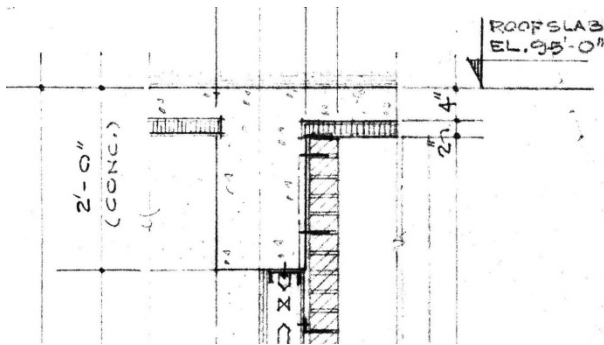
Figure G-11: Section detail at top of interior brick veneer wall at stairway, showing Tectum form plank extending beyond the face of the brick. [From 1968 Drawing A-24, Section 2.]

- i. Quantity: Remove, and subsequently encapsulate, Tectum ceilings at 5 stairways x 300 SF of ceiling area each = approximately 1,500 SF of form plank and mastic removal total.
- ii. Quantity: Remove, and subsequently replace, brick veneer at 5 stairways x 3 courses x 33 LF (average) of veneer brick side wall x 2 walls each = approximately 330 LF total.

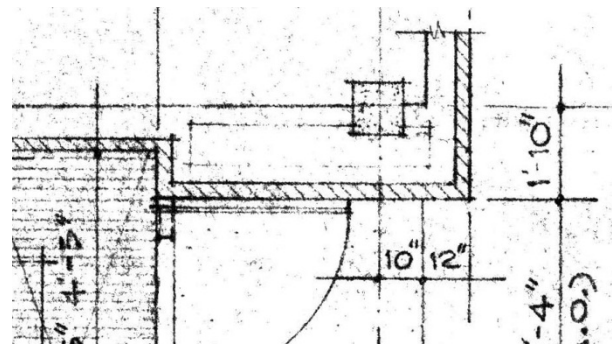
Figure G-12: Enlarged plan at step in brick veneer wall at typical entrance / stairway. [From 1968 Drawing A-23.]

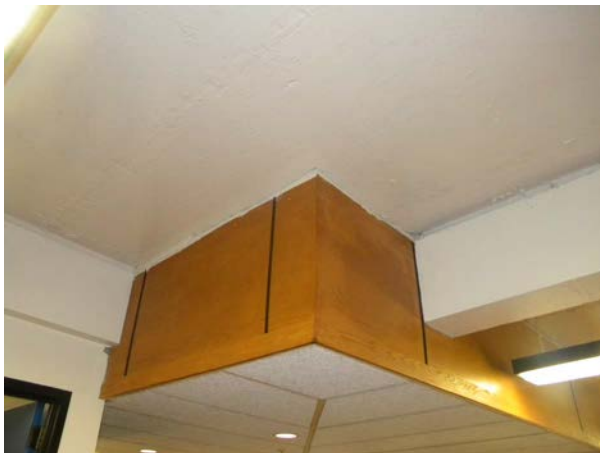
Figure G-16: Soffit and suspended ceiling above serving area in kitchen.

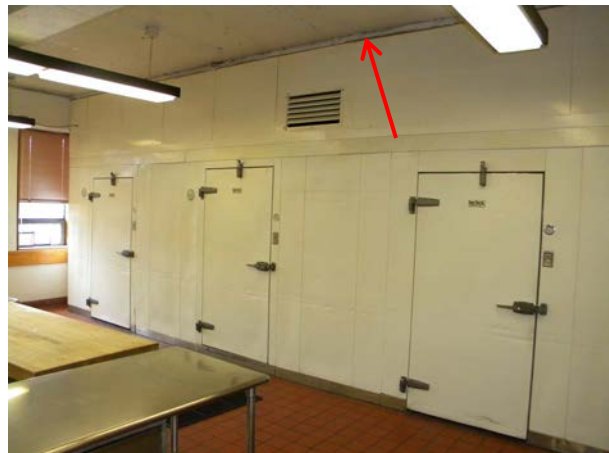
Figure G-17: Tectum form plank above built-in refrigerators and freezers.

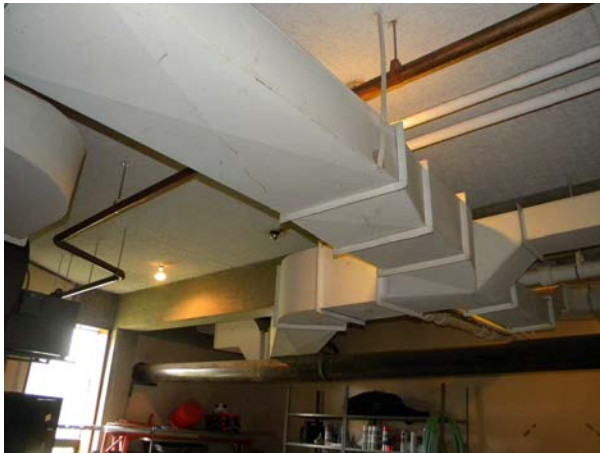
- d. Tectum form plank was not removed from within Lower Level Storage Room 153 during the 2011 project. The presence of existing mechanical equipment and ductwork in this space complicates Tectum and mastic removal.
 - i. Quantity: Remove Tectum form plank, and subsequently encapsulate concrete, at Storage Room 153 = approximately 450 SF total.

Figure G-18: Tectum form plank at Storage Room 153.

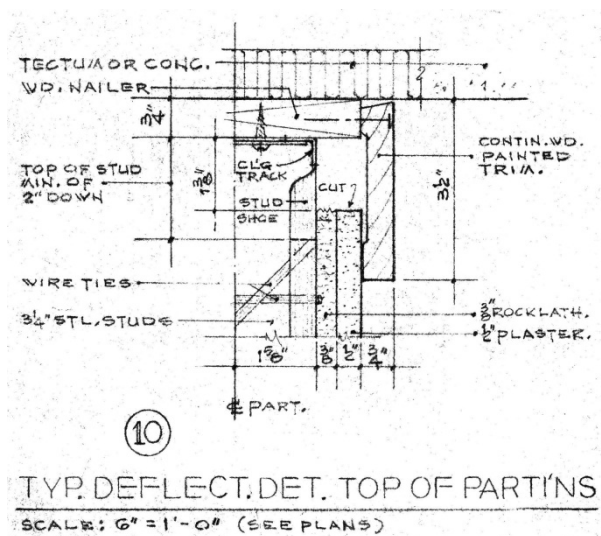
Figure G-19: Typical detail at top of partitions to existing Tectum form plank. [From 1968 Drawing A-26, Detail 10.]

- i. Quantity: Remove Tectum form plank, and subsequently provide new wood blocking and trim, above existing partitions = approximately 2,425 linear feet total.

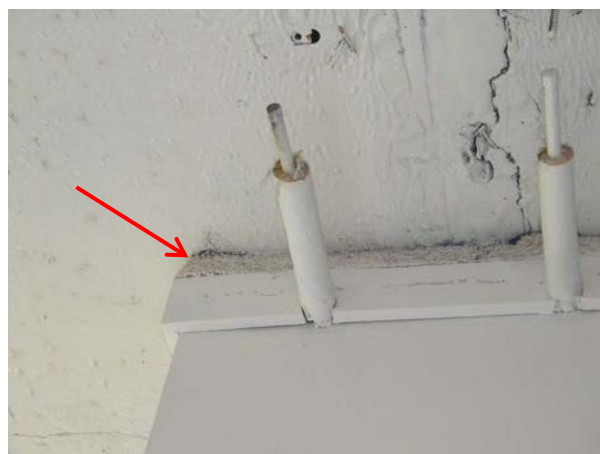
- e. Typical interior steel stud and plaster partitions were built directly to the underside of the Tectum form plank throughout the building. Tectum and mastic at the **tops of these partitions** must be removed. To do so, existing wood trim at the top of the wall should be removed, exposing the wall framing and blocking. Existing wood nailers are anchored through the Tectum form planks into the concrete floor or roof slab above. Removal of the Tectum might result in disconnecting the nailer anchorage, so the work should proceed in alternating 4'-0" segments in order to maintain the necessary top of wall anchorage. (Temporary bracing might also be employed.) Following removal of the Tectum and mastic and the encapsulation of the remaining concrete slab surfaces, the resulting 2" gap above the existing wood nailers should be filled with new wood blocking anchored to the concrete slab, and the existing wood nailers should then be anchored to this new blocking to ensure a well braced partition. New wood trim can be installed as a finish material at the tops of these partitions. Some areas of remaining Tectum form plank yet to be removed were also found above masonry walls in the Band Room.

Figure G-20: Approximately 2" thickness of Tectum form plank remaining at top of typical partitions following the 2011 PCB Source Removal Project.

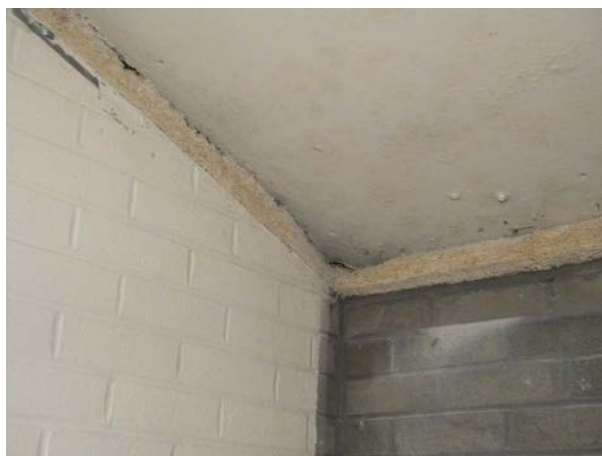
Figure G-21: Tectum form plank remaining at the tops of masonry partitions at the Band Room.

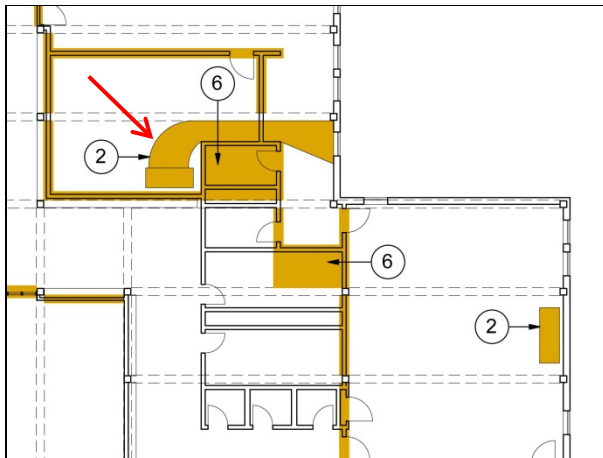
Figure G-22: Partial plan showing locations of Tectum form plank above mechanical equipment (Note 2). Red arrow indicates mechanical equipment and ductwork pictured in Figure G-25, below.

- i. Quantity: Remove Tectum form plank, including removal and reinstallation of mechanical equipment and subsequent encapsulation of concrete ceiling slabs, at 24 classroom unit vents x 22 SF (average) each = approximately 528 SF total.
- ii. Quantity: Remove Tectum form plank, including removal and reinstallation of mechanical equipment and subsequent encapsulation of concrete ceiling slabs, at mechanical equipment and ductwork at 6 other miscellaneous interior locations = approximately 600 SF total.

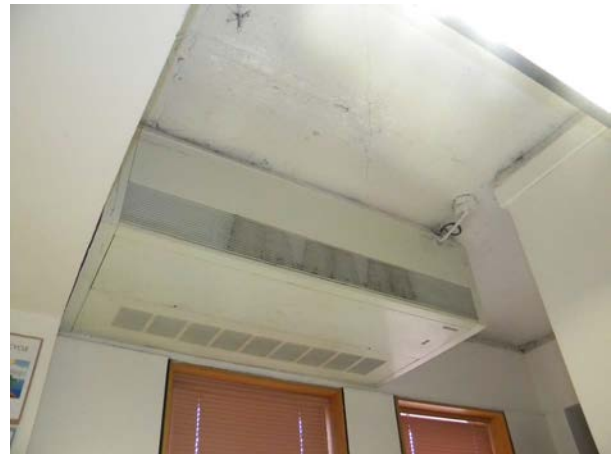
Figure G-23: Typical classroom unit ventilator with Tectum form plank above.

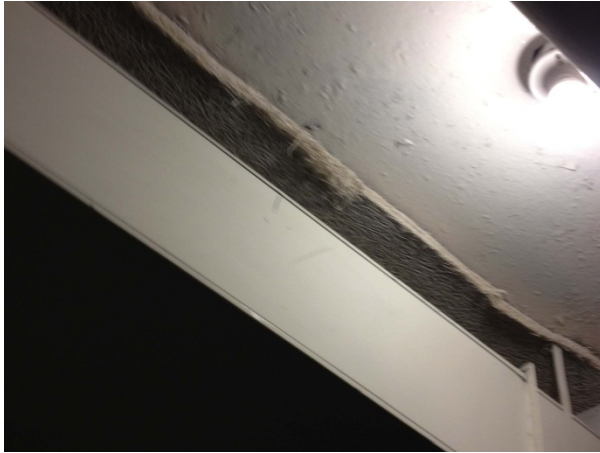
Figure G-24: Tectum form plank above mechanical equipment and ductwork in Gymnasium Storage Room 141.

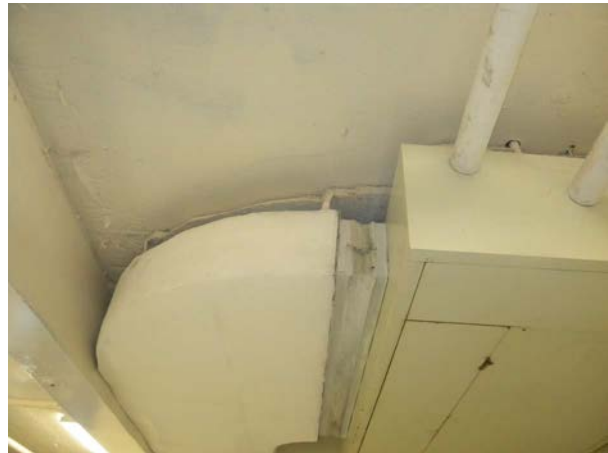
Figure G-25: Tectum form plank above mechanical equipment and ductwork in Special Education Room 155.

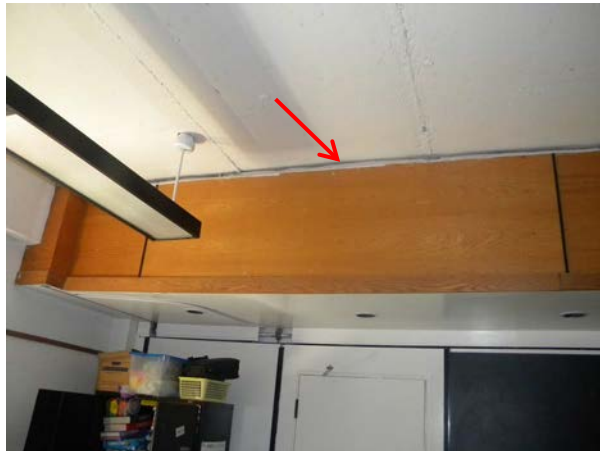
- g. Several areas of the building were constructed with movable (folding) partitions to allow flexibility in arranging classroom spaces. These movable partition assemblies include **ceiling mounted soffits** that conceal existing Tectum form plank above. Eight soffit assemblies, and the five movable partitions they accommodate, must be removed in order to remove the remaining Tectum form plank, scrape off the associated mastic, and encapsulate the exposed concrete ceilings. Three of the movable partitions currently serve as permanent walls between classrooms and should be replaced with new full height steel stud, blue board, and plaster walls.

Figure G-26: Typical soffit construction above movable partitions.

- i. Quantity: Remove 5 movable partition assemblies = approximately 1,500 SF total.
 - ii. Quantity: Remove soffit assemblies and Tectum form plank, and subsequently encapsulate concrete, at 8 soffit assemblies = approximately 1,100 SF total.

- iii. Quantity: Provide 137 LF new partitions (double-sided) x 11'-0" height = approximately 1,500 SF total.

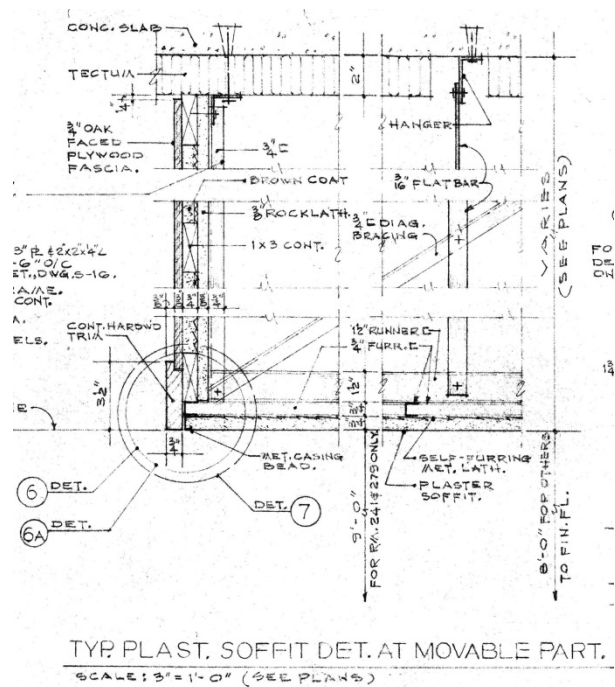
Figure G-27: Typical detail of soffit construction at movable partitions. [From 1968 Drawing A-26]

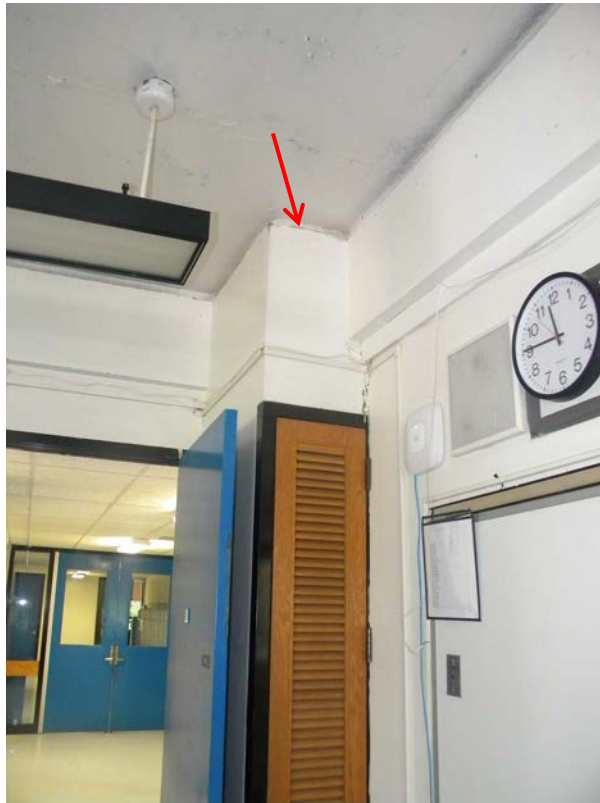
- h. Eight **small teacher's closets** with solid gypsum walls are located in Lower and Upper Level classrooms. These small closets also contain ductwork and registers as part of the building's ventilation (exhaust) system. The top portion of these closets must be removed (and subsequently reconstructed) in order to remove remaining Tectum form plank and associated mastic and to encapsulate the exposed concrete ceilings above.
- i. Quantity: Remove Tectum form plank, and subsequently encapsulate concrete, above 8 closets x 5 SF each = approximately 40 SF total.

Figure G-28: Typical classroom teacher's closet.

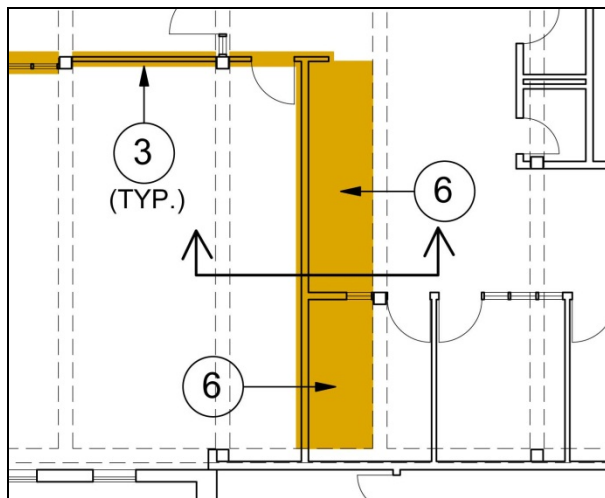
Figure G-29: Partial plan showing remaining portion of Tectum form plank span to be removed above suspended ceiling at corridor and small office space (Note 6). See Figure G-30 for section drawing indicated on plan.

- i. Quantity: Remove Tectum form plank above suspended ceilings (including removal and reinstallation of suspended ceiling systems), and subsequently encapsulate concrete = approximately 1,475 SF x 1.20 (contingency) = approximately 1,770 SF total.

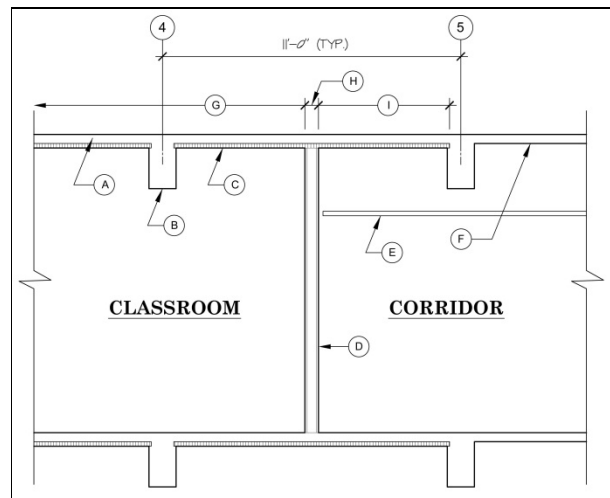
Figure G-30: Section at partition between classroom and corridor. A = concrete roof / floor slab; B = concrete beam; C = Tectum form plank; D = steel stud / plaster partition; E = suspended ceiling; F = bare concrete roof / floor slab (no form plank); G = exposed form plank removed in 2011; H = remaining form plank to be removed at top of partition; I = remaining form plank to be removed above suspended ceiling.

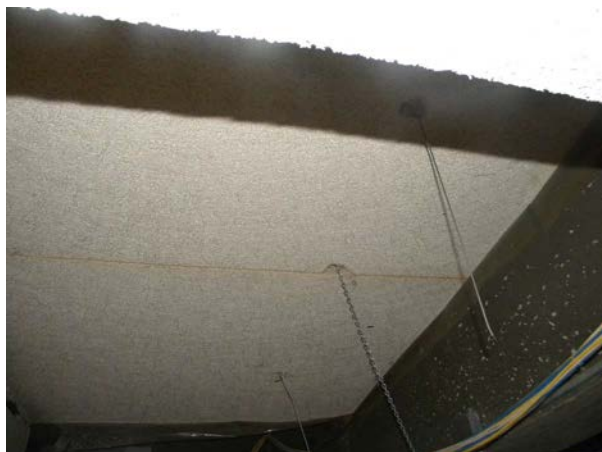
Figure G-31: Tectum form plank concealed above suspended ceiling at corridor.

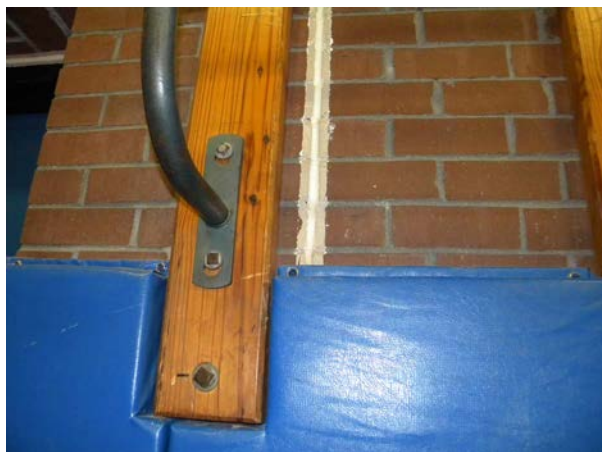
[Figure G-34]. There may be instances where interior caulk still remains above suspended acoustical ceiling tiles, but EnviroScience reported that care was taken to address these areas in 2011, and CGKV found evidence to support this assertion [Figure G-35]. Removal of remaining concealed caulk would require removal and reinstallation of metal lockers, suspended ceiling tiles, wall pads, and the like. Future work will require careful examination to identify hidden sections of interior caulk. CGKV did not identify all locations of possible concealed interior caulk, so an allowance is used here for quantification.

Figure G-34: Interior caulk at expansion / control joint in masonry wall is likely still in place behind wall pads in the gymnasium.

- i. Quantity: Allowance for removal, and subsequent replacement, of concealed interior caulk = approximately 200 LF total

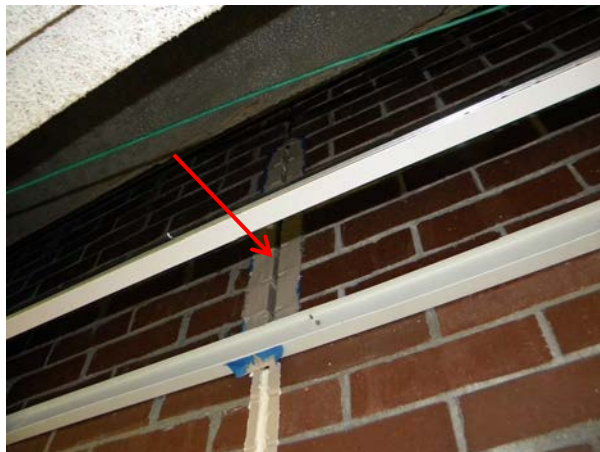
Figure G-35: Interior caulk at expansion joint removed above suspended ceiling tiles.

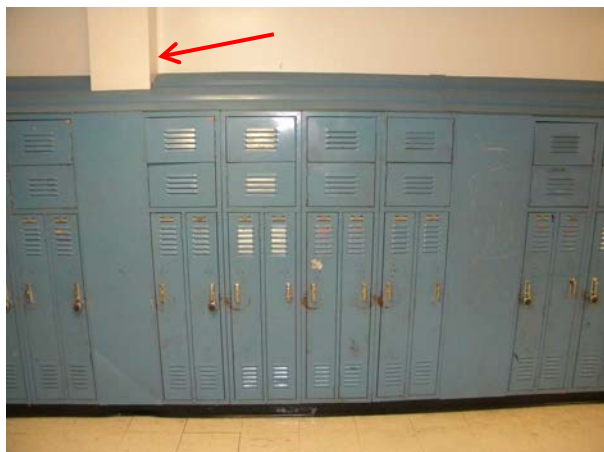
- a. Similar to interior caulk, foam fillers forming the resilient joint between cast-in-place concrete columns and beams and abutting plaster partitions were removed in 2011 where accessible. This **PCB-containing foam** material is likely still present in some concealed locations behind existing metal lockers and chalk boards [Figures G-36 and G-37]. EnviroScience reports that care was taken to remove foam fillers where they extended above suspended ceiling tiles [Figure G-38], though any future work will require careful examination to confirm that hidden sections of foam filler were not left behind [Figure G-39].
 - i. Quantity: Allowance for removal of concealed foam filler = approximately 500 LF total.

Figure G-36: Interior foam filler at joints between concrete columns / beams and steel stud / plaster partitions is indicated by red arrow. This joint with foam filler likely extends down and remains behind existing lockers.

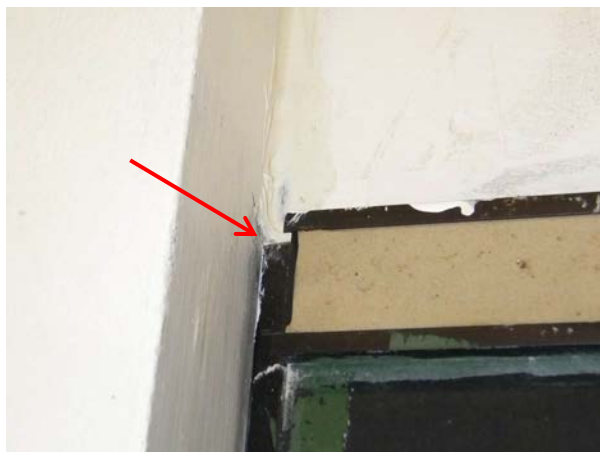
Figure G-37: Foam filler remains where concealed behind edge of existing chalk board.

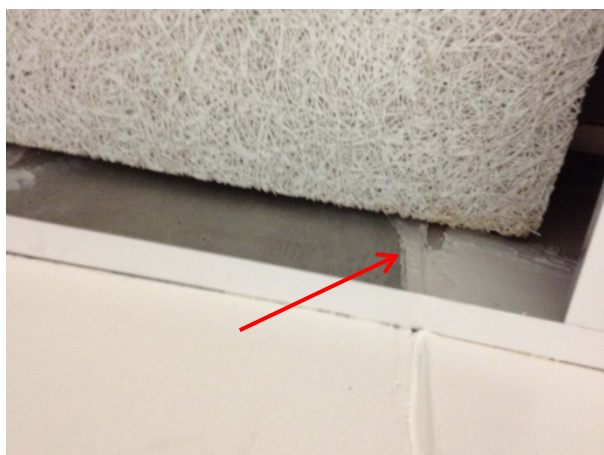
Figure G-38: EnviroScience reported that care was taken to remove foam fillers above existing suspended ceilings.

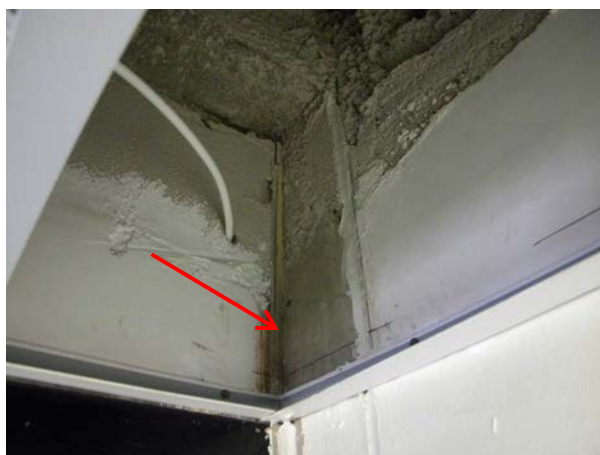
Figure G-39: Red arrow points to segment of foam filler between metal corner bead and concrete column that was not removed in 2011 from above the suspended ceiling at this location.

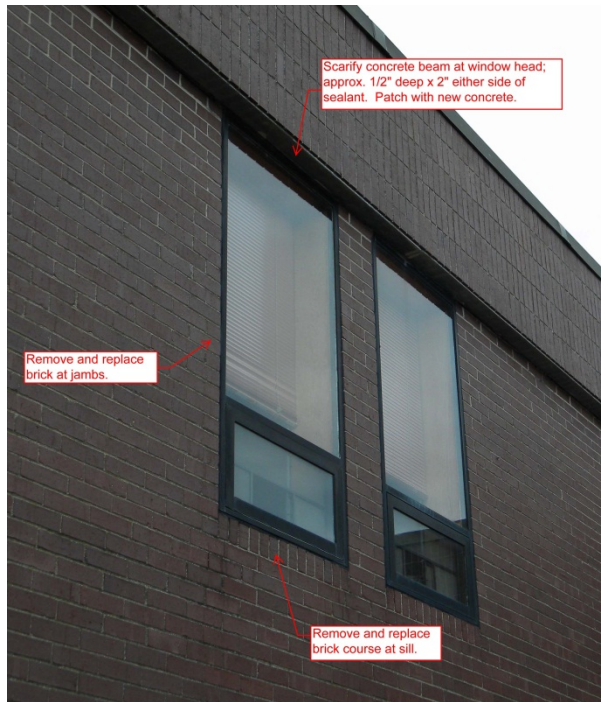
Figure H-01: Existing brick jambs and sill and concrete head at typical Type 'A/A1' windows.

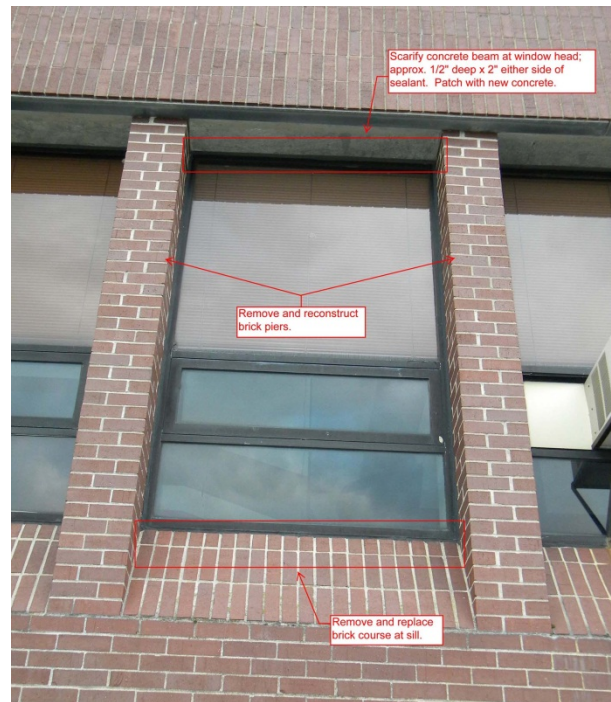
Figure H-02: Existing brick jambs and sill and concrete head at typical Type 'B' windows.

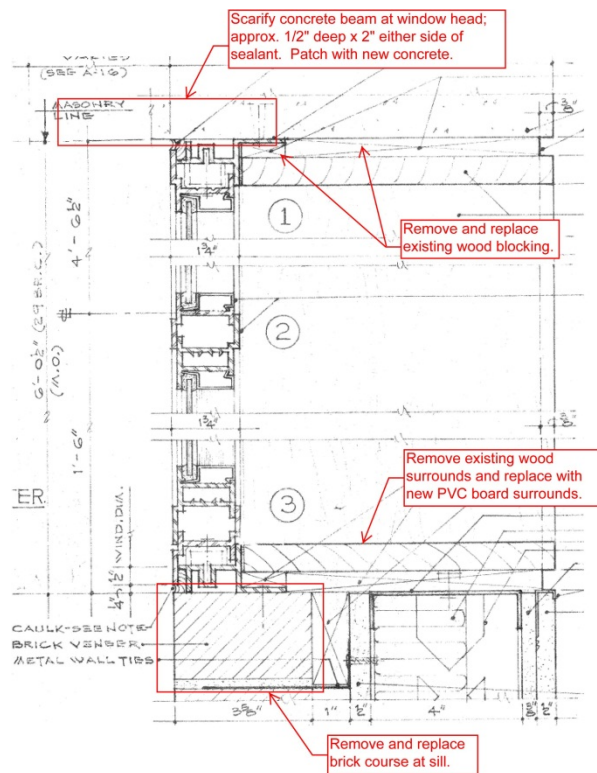
Figure H-03: Vertical details at Type 'A/A1' windows indicating PCB Remediation Wastes to be removed. [From 1968 Drawing A-20]

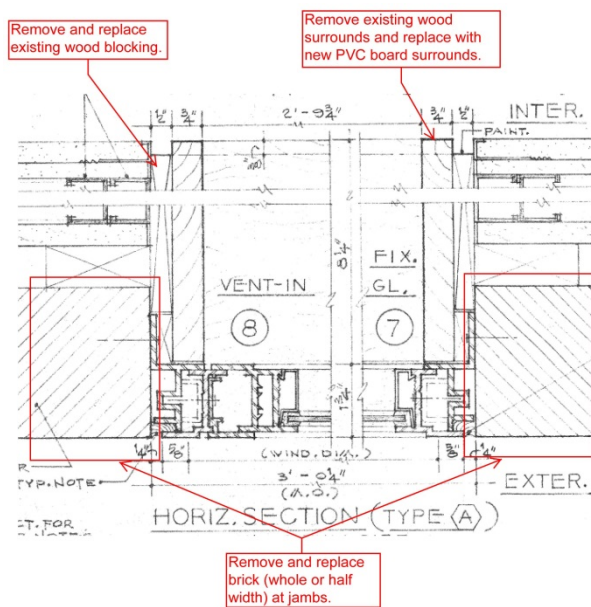
Figure H-04: Horizontal details at Type 'A/A1' windows indicating PCB Remediation Wastes to be removed. [From 1968 Drawing A-20]

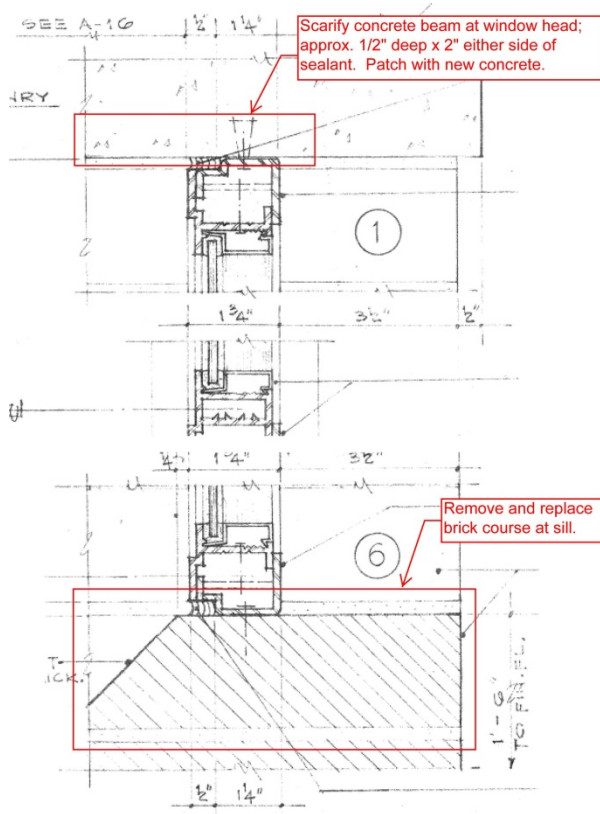
Figure H-05: Vertical details at Type 'B' windows indicating PCB Remediation Wastes to be removed. [From 1968 Drawing A-20]

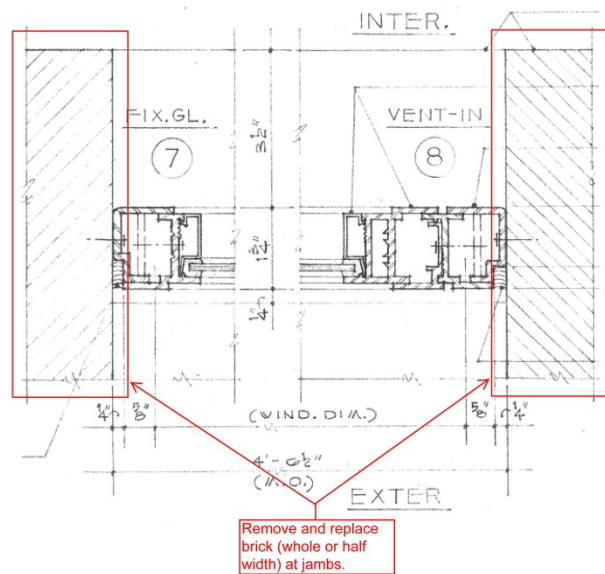
Figure H-06: Horizontal details at Type 'B' windows indicating PCB Remediation Wastes to be removed. [From 1968 Drawing A-20]

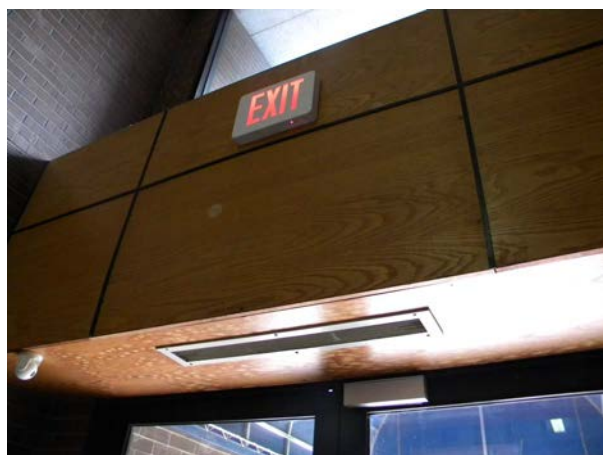
- iii. Quantity: Provide 1 new storefront assembly at receiving area, including soffits and fascia = approximately 416 SF total.
- e. The five two-story exterior door assemblies each support existing cabinet unit heaters located directly above the doors. They are concealed behind an oak plywood enclosure and supply heat to each of the exterior stairways [Figures H-10 and H-11]. In order to replace the exterior door assemblies, the cabinet unit heaters (including piping and control wiring) need to be removed and reinstalled. The storefront assembly in the receiving area also supports a finned tube heat source with plywood enclosures [Figure H-12]. This mechanical system must be removed and reinstalled, too.**

Figure H-10: Existing cabinet unit heater enclosure above typical two-story exterior door assembly head.

- i. Quantity: Remove and reinstall cabinet unit heaters and plywood enclosures at 5 exterior door assemblies.
 - ii. Quantity: Remove and reinstall approximately 20 LF finned tube radiation and plywood enclosure at receiving area storefront.

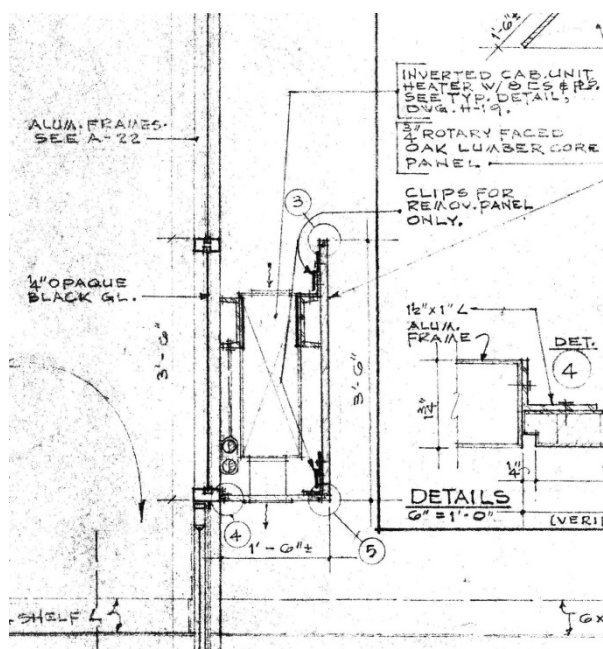
Figure H-11: Detail of typical cabinet unit heater at two-story exterior door assembly head. [From 1968 Drawing A-24]

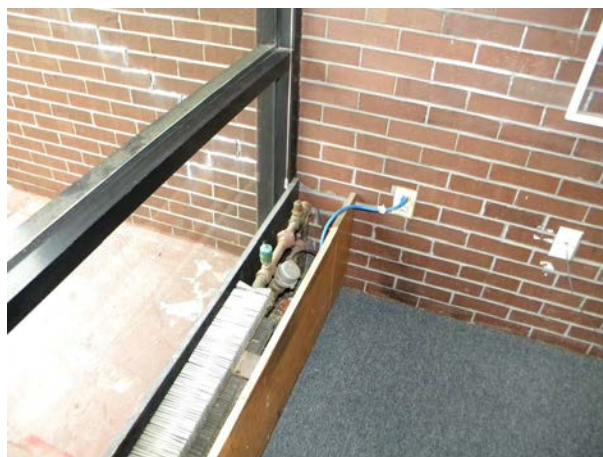
Figure H-12: Finned tube heat source mounted to storefront assembly at receiving area.

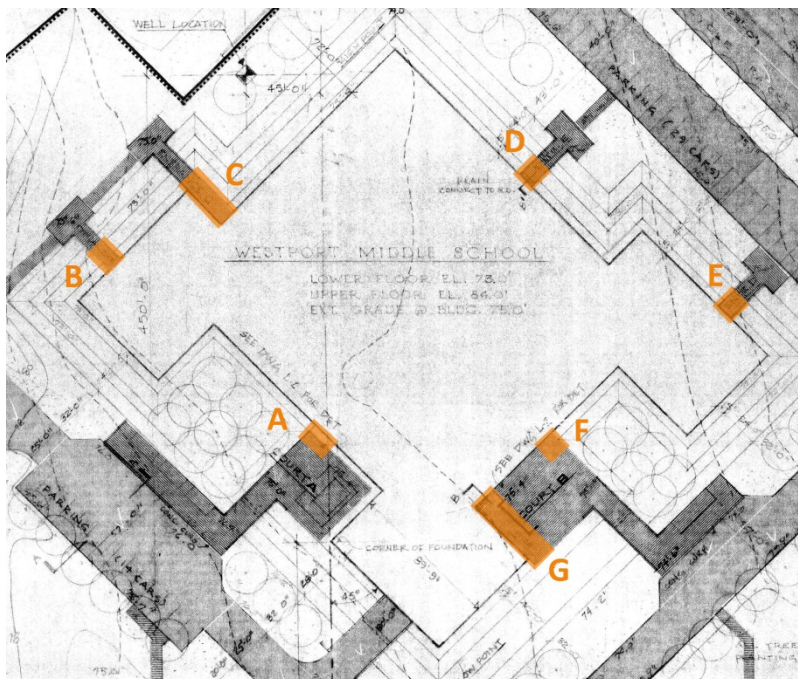
EnviroScience sampled concrete in the exterior walkway outside Door No. 100 (near Classroom 166) and found that it contained PCBs >1 ppm at a depth range of 0" to 1/2". Based on this result, this study surmises that all concrete walkways immediately adjacent to the building perimeter must be treated as PCB Remediation Waste. The definitive extent of PCB contamination in exterior walkways must be confirmed through further sampling and testing.

Figure H-13: Exterior concrete walkways at building entrances / exits. [From 1968 Drawing L-1]

- a. Exterior concrete walkways meet the building at each of the seven exterior door assemblies at the Lower Level (or at an intermediate level a few steps above the Lower Level). It is presumed in this Study that concrete slabs on grade should be removed and replaced in their entirety at each of these locations to a distance of at least 5'-0" from the building drip line. Walkways parallel to exterior walls (e.g. - locations C and G in Figure H-13) are proposed to be replaced full width.**
 - i. Quantity: Remove and replace reinforced concrete slab-on-grade walkways at seven building entrances = approximately 1,430 SF total.
