CGKV Architects, Inc.

FEASIBILITY STUDY FOR THE ON-GOING USE OF WESTPORT MIDDLE SCHOOL

**400 OLD COUNTY ROAD
WESTPORT, MASSACHUSETTS**

SEPTEMBER 23, 2013

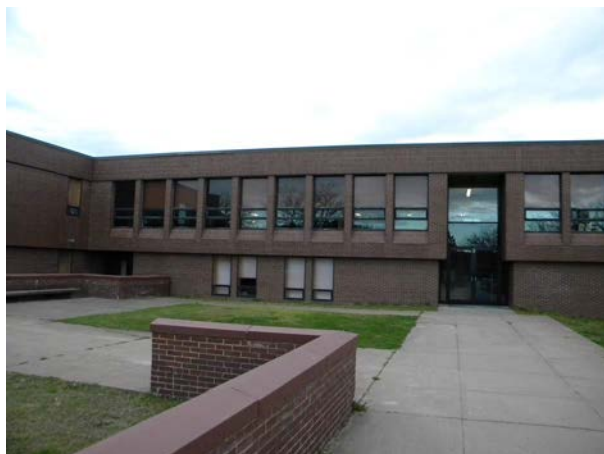
Figure H-14: Exterior walkways near doors 75 and 81 (locations G and F from plan above).

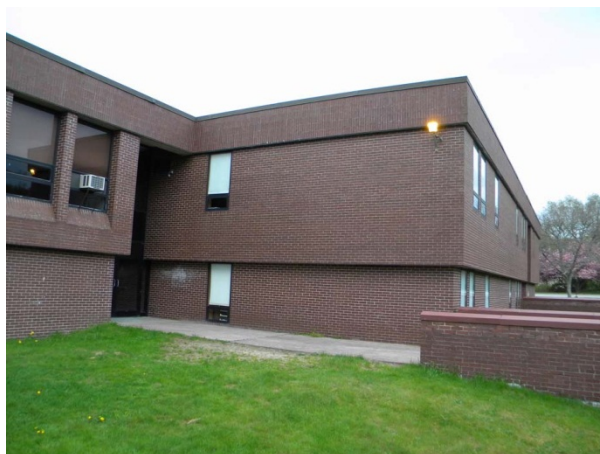
Figure H-15: Exterior walkway near door 30 (location C from plan above).

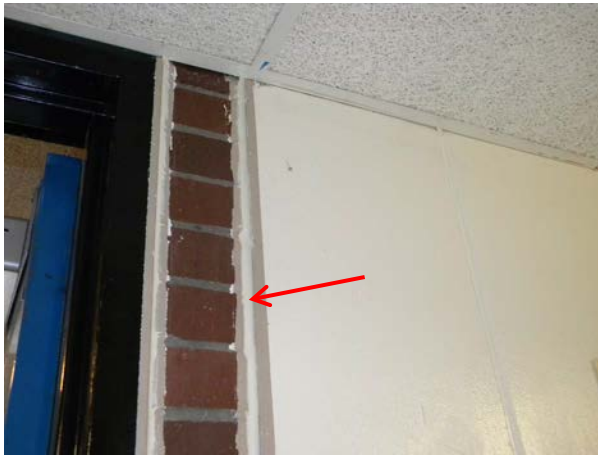
- a. Caulk joints at brick veneer to concrete columns occur at all five main stairways at the building perimeter. Removal of PCBs absorbed into the brick and concrete could involve removal and replacement of whole- and half-bricks as well as scarification and parging of concrete columns immediately adjacent to the caulk joints. These joints extend full height above existing suspended ceilings, which would need to be removed and reinstalled to complete the work. Steel doors and frames from the stairways to the main corridors would need to be removed and reinstalled at three locations where they are in close proximity to the caulk joint.

Figure H-16: Joint at brick to concrete at stairways. (Note stripes of gray epoxy encapsulant at either side of existing joint applied in 2011.)

- i. Quantity: Remove, and subsequently replace, backer rod and caulk between brick veneer and concrete columns, 11 LF x 2 joints per stairway x 5 stairways x 2 floors = approximately 220 LF total.

- ii. Quantity: Remove, and subsequently rebuild, one brick veneer wythe x 8" width x 11 LF per side x 2 sides x 5 stairways x 2 floors = approximately 220 LF total.

- iii. Quantity: Remove, and subsequently parge, 1/2" depth concrete x 4" width x 11 LF per side x 2 sides x 5 stairways x 2 floors = approximately 220 LF total.
- iv. Quantity: Remove, and subsequently reinstall, 60 SF suspended ceiling system x 5 landings x 2 floors = approximately 600 SF total.
- v. Quantity: Remove, and subsequently reinstall, 3 steel-framed door, fixed lite, and fascia assemblies (including backer rod and caulk) x 100 SF each = approximately 300 SF total.

- b. Encapsulation of brick veneer and concrete surfaces on either side of the caulk joint, with a painted epoxy coating, is a recommended alternative to full removal of PCB Remediation Wastes. This method was generally employed during the 2011 PCB Source Removal Project, with a narrow strip of encapsulant painted over the brick and concrete edges on either side of the caulk joint. For an improved and more consistent appearance than currently exists, all contiguous exposed surfaces of brick veneer and concrete columns should be painted with encapsulant. This work might require removal and reinstallation of suspended ceilings, but existing steel-framed door and fixed-lite assemblies may remain in place.**
 - i. Quantity: Encapsulate concrete columns with epoxy paint x 17 SF per column (average) x 2 columns per stairway x 5 stairways x 2 floors = approximately 340 SF total.

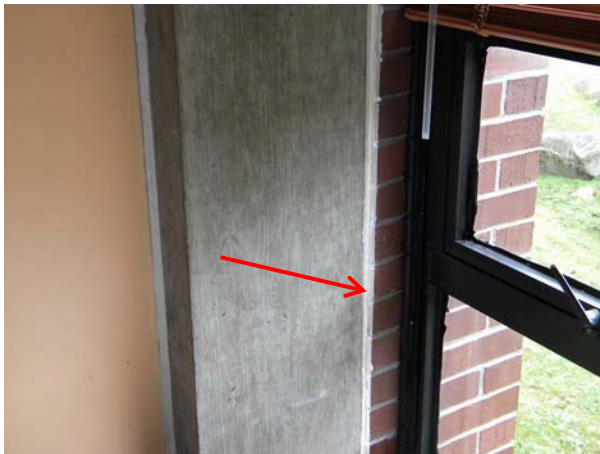
Figure H-19: Joint at brick to concrete at piers.

- d. As an alternative to scarifying and patching contaminated concrete, the concrete columns can be encapsulated with an epoxy coating. For a more consistent appearance, it is recommended that all exposed surfaces of the columns be encapsulated.
 - i. Quantity: Encapsulate concrete columns with epoxy paint x 33 SF per column (average) x 21 columns = approximately 693 SF total.
 - ii. Quantity: Encapsulate concrete columns with epoxy paint x 17 SF per column (average) x 5 columns = approximately 85 SF total.

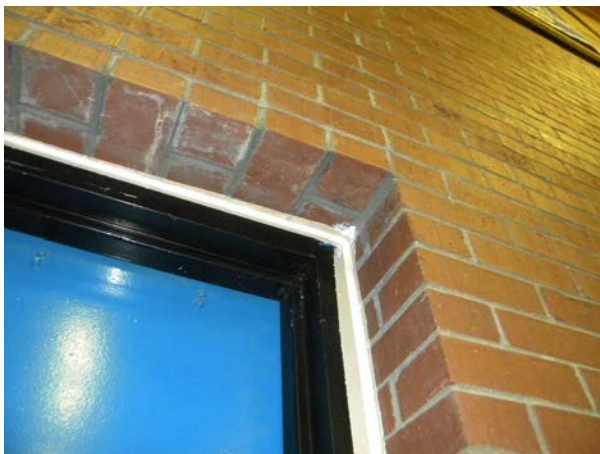
Figure H-21: Joint at steel frames to reinforced masonry walls.

- h. As with other brick surfaces listed above, reinforced brick masonry at steel frame jambs and heads may be left in place and encapsulated with an “accent band” epoxy coating at both sides of the frame.**
 - i. Quantity: Encapsulate exposed brick jambs and heads with epoxy paint “accent band”, 12” wide x 23 LF per opening (average) x 15 openings x 2 sides each = approximately 690 SF total.

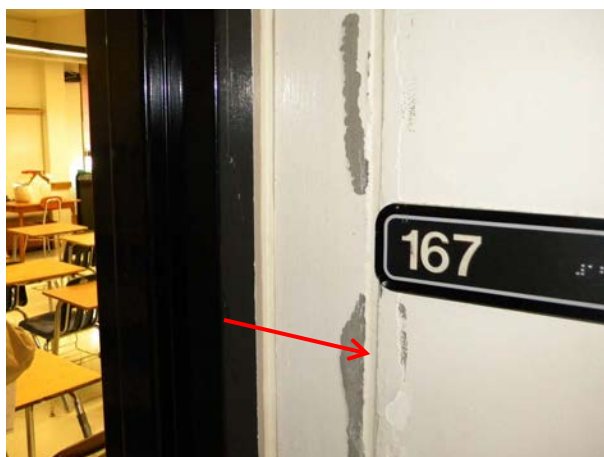
Figure H-24: Joint at concrete column to plaster wall.

- n. In lieu of scarifying concrete and removing and re-building plaster partitions, contaminated surfaces of concrete columns and beams can be encapsulated with an epoxy coating. For a consistent appearance, all exposed surfaces of concrete columns and beams adjacent to plaster partitions should be painted.**
 - i. Quantity: Encapsulate 136 concrete columns with epoxy paint x 24" wide (average) 11 LF tall = approximately 2,992 SF total.
 - ii. Quantity: Encapsulate 127 concrete columns with epoxy paint x 48" wide (average) 11 LF tall = approximately 5,588 SF total.
 - iii. Quantity: Encapsulate concrete beams with epoxy paint x 30" wide (average) 2,520 LF long = approximately 6,300 SF total.
 - iv. Quantity: Encapsulate concrete beams with epoxy paint x 52" wide (average) 1,325 LF long = approximately 5,742 SF total.

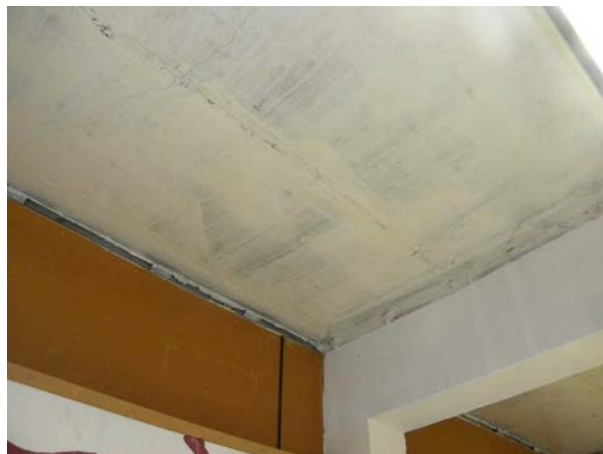
in the construction. Concrete was found to be contaminated with PCBs at >1 ppm. This suggests that typical cast-in-place concrete columns, beams, and ceilings that were not in direct contact with any known PCB Bulk Products may have absorbed PCBs through the air or through dust. It stands to reason that the cast-in-place concrete ceilings that were in direct contact with PCB-containing mastics associated with Tectum form plank are also contaminated and would be classified as PCB Remediation Waste.

Figure H-25: Cast-in-place concrete columns, beams, and slabs.

- b. In lieu of removing a 1/2" deep layer of material from essentially all accessible concrete surfaces in the building, those surfaces can be left intact and encapsulated with a painted epoxy coating.**
 - i. Quantity: Encapsulate concrete columns with epoxy paint at 394 columns = approximately 14,347 SF total.
 - ii. Quantity: Encapsulate concrete beams with epoxy paint = approximately 44,893 SF total.

- iii. Quantity: Encapsulate concrete ceilings with epoxy paint = approximately 85,175 SF total.

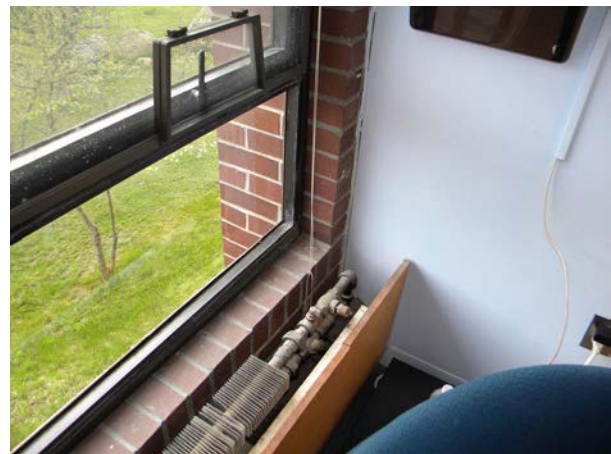
Figure H-27: Finned tube radiator and plywood cover at typical Type 'B' windows.

- a. Exposed brick walls at Upper Level spaces with Type 'B' windows are of brick veneer construction. Along with the work to remove and reconstruct brick piers and sills described in Section I.1 above, the remaining interior wythe of brick veneer from the sill to the floor can likewise be removed and re-built. Finned tube radiation, with a plywood enclosure, must be removed and reinstalled from in front of the brick veneer in order to accomplish this work.**
 - i. Quantity: Remove, and subsequently reinstall, 531 LF of finned tube radiation with plywood enclosure = approximately 531 LF total.
 - ii. Quantity: Remove, and subsequently rebuild, one interior wythe of brick veneer x 1'-4" high x 531 LF = approximately 708 SF total.

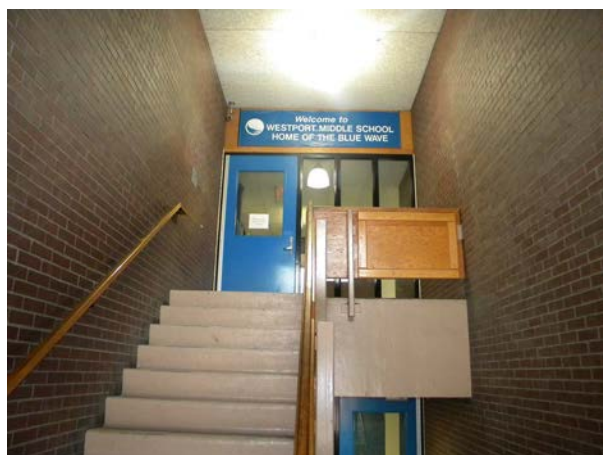
Figure H-28: Brick veneer walls at stairways.

- b. Two-story high walls inside the five main stairways are also of brick veneer construction. The brick veneer can be removed in its entirety, leaving the existing wall sheathing and steel stud back-up structure in place, and new brick veneer can be subsequently installed. Work would require removal and reinstallation of wall-mounted handrails.
 - i. Quantity: Remove, and subsequently reinstall, 22 LF wall-mounted handrail x 5 stairways = approximately 110 LF total.
 - ii. Quantity: Remove, and subsequently rebuild, 550 SF brick veneer x 2 walls x 5 stairways = approximately 5,500 SF total.
- c. The interior walls between central Gymnasium and Auditorium spaces and the main corridor that rings them are of reinforced brick masonry

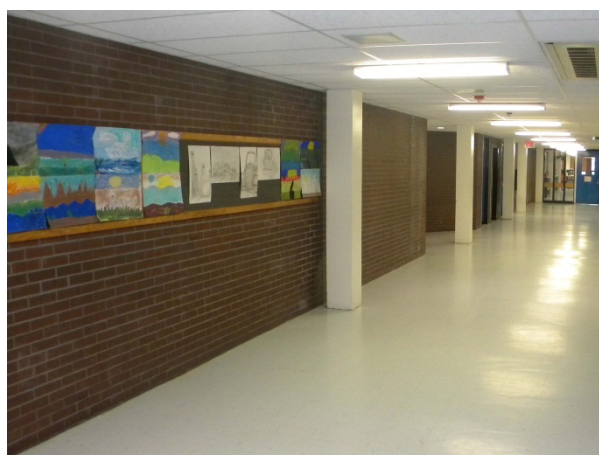
construction. Full wythes of brick cannot be removed without impacting the structural performance of these walls. In order to remove PCB contaminated brick material, it may be possible to remove just the outermost 1/2" face of the brick. The remaining rough brick substrate can subsequently be parged with a compatible cementitious material, leaving behind a plaster-like finished surface. Lockers at the Lower Level, shelving in the Media Center at the Upper Level, and miscellaneous wall-mounted items would need to be removed and reinstalled.

Figure H-29: Reinforced brick masonry walls at corridors.

- i. Quantity: Remove, and subsequently reinstall, 260 LF of existing lockers = approximately 260 LF total.
- ii. Quantity: Remove, and subsequently reinstall, 100 LF of existing shelving = approximately 100 LF total.
- iii. Quantity: Remove, and subsequently parge, 1/2" depth of existing brick walls = approximately 11,100 SF total.

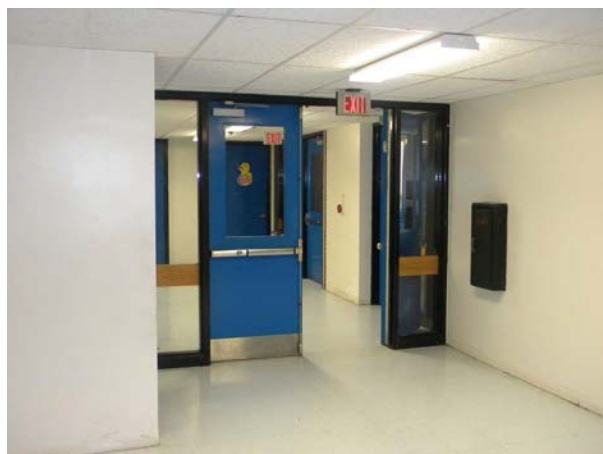
The majority of walls inside Westport Middle School are constructed of light gauge steel stud framing with 3/8" rock lath and 1/2" plaster. Plaster surfaces are typically painted. EnviroScience measured PCB concentrations in paint at Westport Middle School from >1 ppm to >50 ppm, and USEPA research indicates that certain kinds of paint can be strong PCB sinks (see Figure D-08). USEPA also found that gypsum wall board (a building material used in similar fashion as plaster) can be a PCB sink. EnviroScience did not sample and test plaster materials behind painted surfaces, and USEPA research referenced above also did not test absorption of PCBs past a layer of paint. Subject to confirmation through testing, it is possible that PCBs were absorbed through the paint and into the plaster substrates at Westport Middle School.

Figure H-30: Painted plaster walls at corridor.

an epoxy coating. This approach will require that special procedures be followed when anchoring or fastening any new items to the existing walls.**

- i. Quantity: Encapsulate painted plaster walls with epoxy paint = approximately 110,000 SF total.

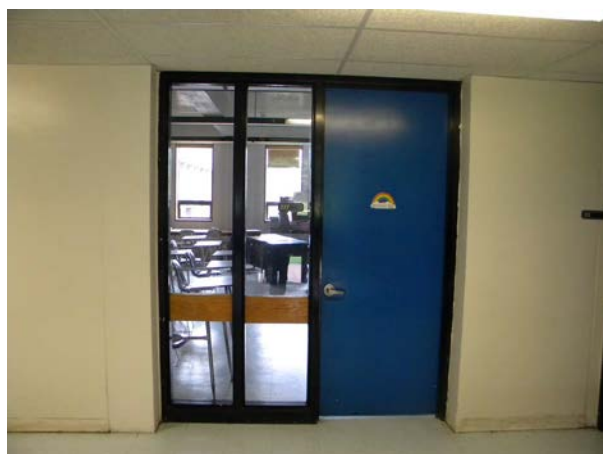
Figure H-31: Steel-framed door and fixed lite assembly from corridor to classroom.

- i. Quantity: Remove, and subsequently replace, glass and stops at fixed lite assemblies = approximately 4,300 SF total.
- b. With the glass removed from the steel frames, all frames, as well as the hollow metal doors, can be thoroughly stripped (or abraded) of PCB-contaminated paint down to bare metal. All steel frames and hollow metal doors can then be re-painted.**
 - i. Quantity: Strip, and subsequently re-paint, 262 hollow metal doors x 24 SF each (average) x 2 sides = approximately 6,288 SF total.
 - ii. Quantity: Strip, and subsequently re-paint, steel frames (2" faces x 6" depth, average) = approximately 8,500 LF total.
- [c. Steel is non-porous and will not absorb PCBs. An alternative to leaving steel-framed door and fixed lite assemblies in place and stripping them of PCB-contaminated paint would be to remove these assemblies in their entirety and replace them.]

- d. It may be possible to encapsulate PCB-contaminated glazing compound at interior fixed lites by installing a new bead of sealant between the stops and the glass. Wood rails that are a part of the fixed lite assembly could be encapsulated with an epoxy paint.
 - i. Quantity: Provide new sealant at perimeter of all fixed lite panes = approximately 11,750 LF total.
 - ii. Quantity: Encapsulate with epoxy paint, 525 LF wood rails x 9" surface height (including depth) x 2 sides = approximately 788 SF total.
- e. In lieu of stripping and re-painting all steel doors and frames, the surfaces can be encapsulated with an epoxy paint.
 - i. Quantity: Encapsulate with epoxy paint, 262 hollow metal doors x 24 SF each (average) x 2 sides = approximately 6,288 SF total.
 - ii. Quantity: Encapsulate with epoxy paint steel frames (2" faces x 6" depth, average) = approximately 8,500 LF total.

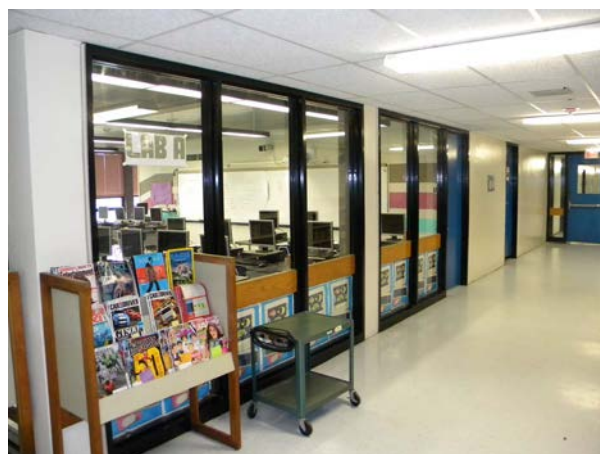
Figure H-32: Steel-framed door and fixed lite assemblies at Media Center.

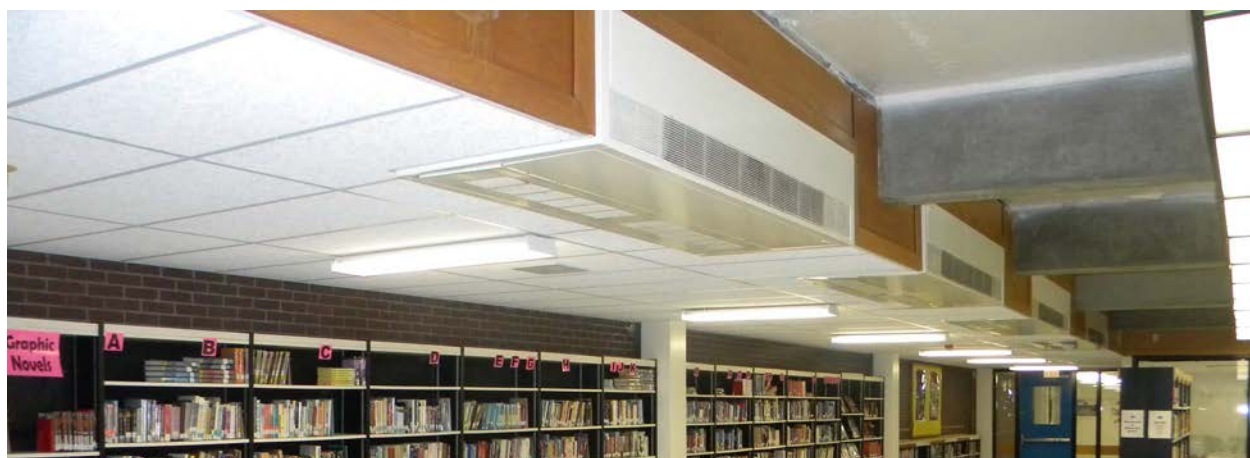
Figure H-34: Acoustical tile ceiling and plywood fascia at Media Center.

- a. All suspended acoustical ceiling panels should be removed and disposed of as PCB Remediation Waste. CGKV recommends removal of the existing suspended metal grid as well; its reuse might not be compatible with currently available acoustical ceiling tiles. The work would also require removal and reinstallation of surface-mounted or recessed items such as lighting fixtures, HVAC registers, smoke detectors, fire alarm devices, speakers, and exit signs.**

- b. CGKV also recommends removal, and subsequent reconstruction, of plywood fascias at transitions in ceiling height.**
 - i. Quantity: Remove, and subsequently replace, plywood fascia assemblies, 145 LF x 1'-0" high (average) = approximately 145 SF total.

- c. The highly textured surface of the existing suspended Tectum ceiling panels would be difficult to paint, and CGKV does not recommend encapsulation as an effective alternative to removal.
- d. Plywood fascias can be encapsulated with an epoxy coating.
 - i. Quantity: Paint plywood fascias with epoxy coating = approximately 3,167 SF total.

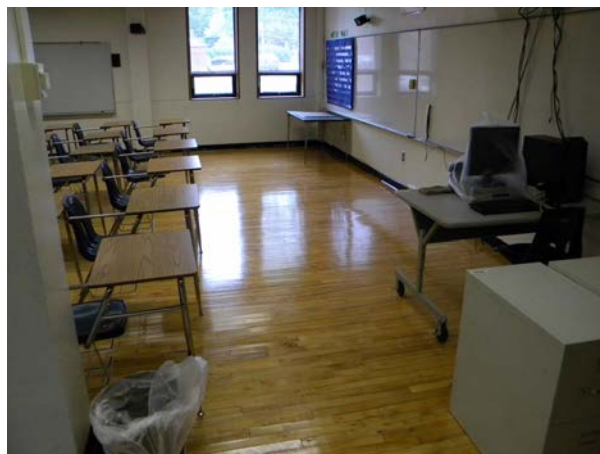
Figure H-36: Existing wood floor at Lower Level Classroom 105.

- b. If existing wood floors in the area of rooms 101 through 107 are found to be contaminated with PCBs >1 ppm, they should be removed and replaced with new plywood underlayment and VCT.**

- i. Quantity: Remove existing wood flooring and subsequently replace with new plywood underlayment and VCT = approximately 5,500 SF total.
- c. All existing resilient base throughout the building should be removed, including mastics, and replaced with new resilient base. This work might require decontamination of the bottoms of walls directly in contact with PCB-contaminated mastic.**

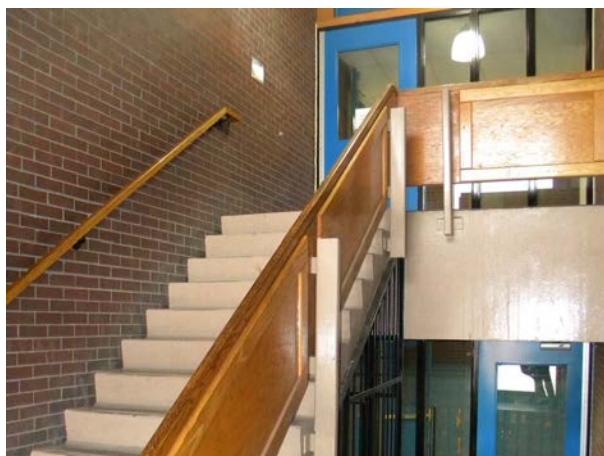
Figure H-37: Wood guardrails and handrails at stairway.

- e. USEPA Researchers identified wood flooring as a PCB sink. By extension, any interior wood material may be porous to a degree allowing contamination with PCBs through the air or dust. Wood trim associated with removal and replacement of exterior windows is already proposed to be replaced in Section G.2.c, above; wood trim at the tops of interior steel stud and plaster partitions is proposed to be replaced in Section G.3.e, above; rails that are a part of typical fixed lite assemblies are proposed to be replaced (or encapsulated) in Section H.9, above; and wood fascias associated with transitions in ceiling height / material are proposed to be replaced (or encapsulated) in Section H.10, above. Other remaining interior wood trim can be found at protective railings at stairways. These wood railings can be removed and replaced.**

- i. Quantity: Remove, and subsequently replace, wood panel guardrails / handrails at stairways = approximately 175 LF total.
 - ii. Quantity: Remove, and subsequently replace, wall-mounted wood handrails at stairways = approximately 200 LF total.

- f. It may be possible to encapsulate existing wood rails at stairways with epoxy paint. However, since these building components are intended to be handled by building occupants, it may be preferable to replace them.

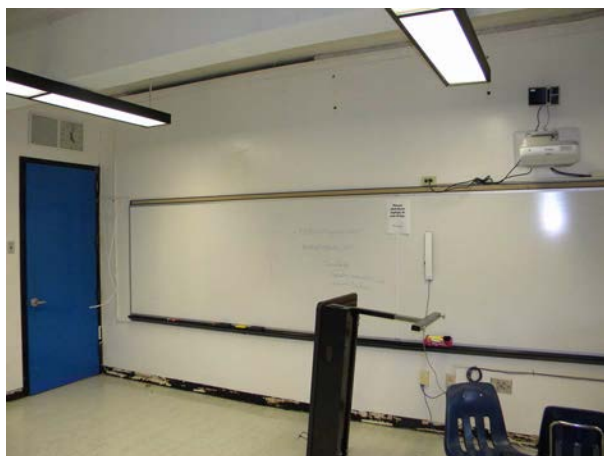
Figure H-38: White board installed over original chalkboard in classroom.

- g. The degree to which interior chalkboards, tack boards, or white boards may be contaminated with PCBs has not been evaluated. Removal and replacement of these visual display boards may be warranted.**
 - i. Quantity: Remove, and subsequently replace, 133 visual display boards x 42.5 SF each (average) = approximately 5,650 SF total.

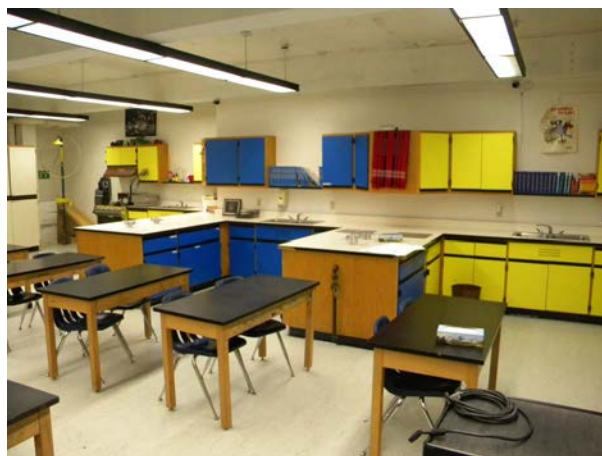
Figure H-39: Existing interior casework in Classroom 268.

- i. Remove, and subsequently replace, base cabinets with countertop (average) = approximately 930 LF total.

- j. CGKV does not recommend encapsulating existing interior casework through epoxy painting or replacement of plastic laminates.

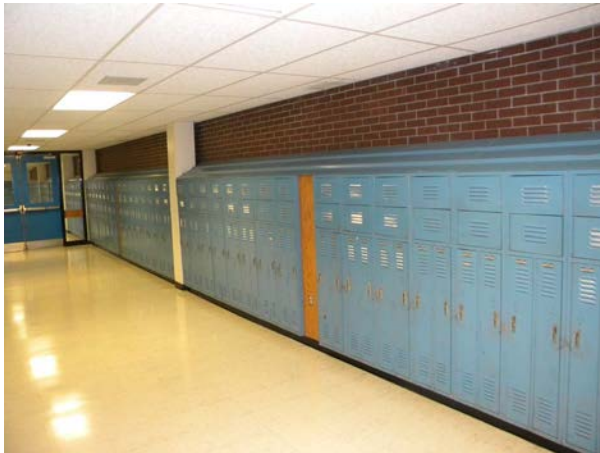
- k. Metal lockers are typically factory-painted. It is not known whether factory paint is susceptible to contamination with PCBs. There is evidence to suggest that many of the lockers at Westport Middle School were field painted at some point after their initial installation. Possible contamination of metal lockers must still be confirmed prior to undergoing a project to remove and replace them.**
 - i. Quantity: Remove, and subsequently replace, typical corridor lockers x 670 LF x 5'-0" height (average) = approximately 670 LF total.
 - ii. Quantity: Remove, and subsequently replace, gymnasium (locker room) lockers x 370 LF x 5'-0" height (average) = approximately 370 LF total.

1. Existing metal lockers are in generally poor condition, and encapsulating them with an epoxy paint is not recommended.
 - i. Quantity: Encapsulate existing metal lockers, outside and inside, with epoxy paint x 1,040 LF x 5'-0" height (average) = approximately 1,040 LF total.

Figure H-40: Existing metal corridor lockers.

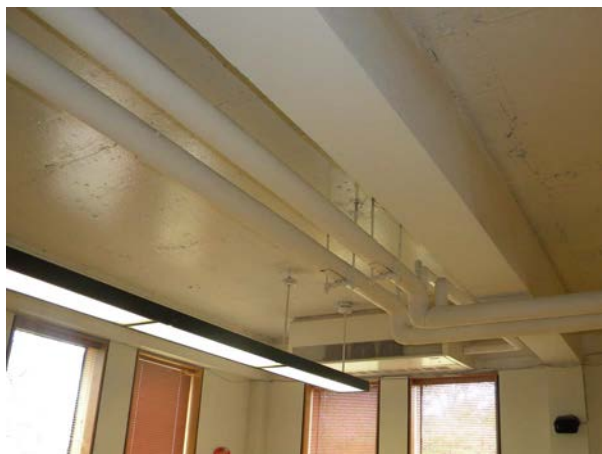
Figure I-03: Existing exposed concrete ceiling at classroom.

- i. Quantity: Adhere acoustical tile panels to existing exposed concrete ceilings = approximately 54,200 SF total.
- b. A second approach would be to **install acoustical ceiling tiles in a conventional suspended metal grid**, similar to the replacement of suspended ceilings discussed in Section H.10. Suspended ceilings may be installed to within 6" of the existing concrete ceilings, thus leaving concrete beams exposed and providing a higher finished ceiling similar to the original design, or they may be installed below the beams, at a height of between 8'-0" and 9'-0", thus allowing the concealment of new pipes, conduit, ducts, or cable that might be installed as part of a major renovation project. The suspended acoustical ceiling allows easier visual monitoring of the encapsulated concrete ceiling above.

- i. Quantity: Install suspended acoustical tile ceiling system below existing exposed concrete ceilings = approximately 54,200 SF total.

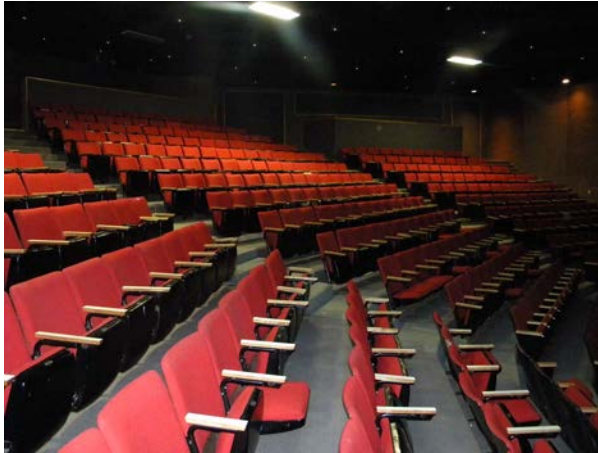
Air sample results within the existing auditorium space at Westport Middle School did not show any elevated concentrations of PCBs in that space. No materials or surfaces inside the auditorium were identified as PCB Bulk Products or PCB Remediation Wastes. The auditorium would benefit from some cosmetic improvements, however. **Seating upholstery** is probably original and is worn, and the seat springs and suspension are uncomfortable. **Carpeting** is beginning to show wear and is loose and wrinkling in some areas.

Figure I-06: Existing auditorium.

- a. Elective improvements to the auditorium space could include replacement of seating and replacement of carpeting.
 - i. Quantity: Replace auditorium seating = approximately 402 seats total.
 - ii. Quantity: Replace auditorium carpeting = approximately 5,000 SF (including risers) total.

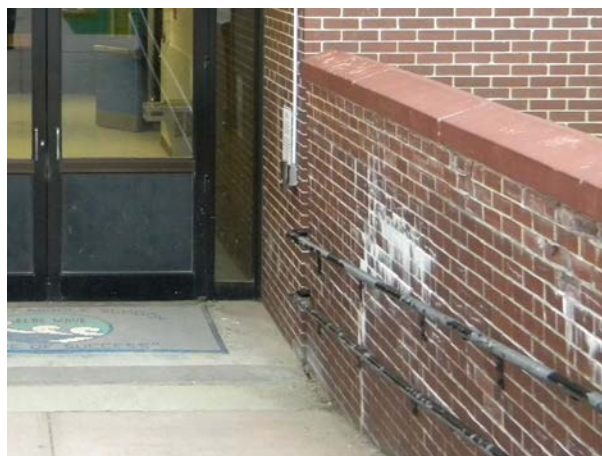
Figure I-09: Efflorescence at exterior brick walls at entrance ramp.

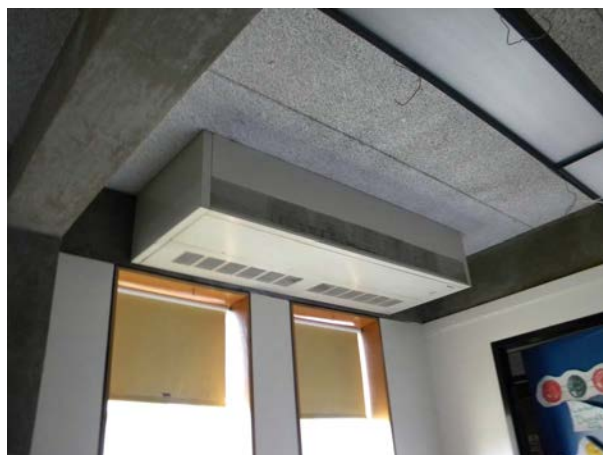
Figure I-10: Existing ceiling mounted unit ventilator. (Note: Photo is from before 2011 PCB Removal Project.)

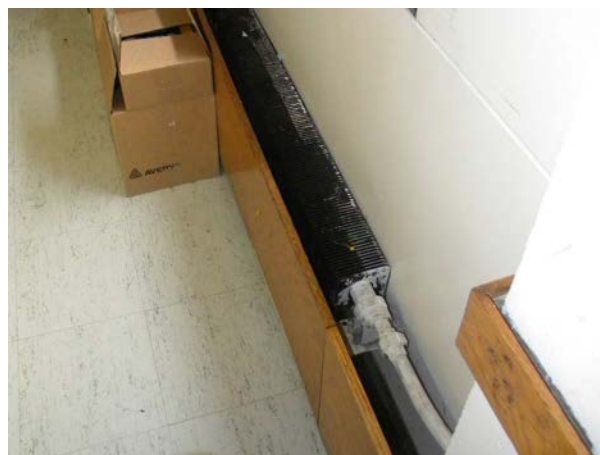
- b. **Hot water piping and finned tube radiators** circulate hot water from the boilers and are the principal heat source for classrooms and other areas of the building. The steel piping has reached its normal life expectancy of 35 to 45 years. Proposed work to remove PCB Remediation Waste at interior brick veneer at Upper Level perimeter walls associated with Type 'B' windows requires the removal and reinstallation of pipes and finned tube radiation (see Section H.7.a). As with the unit ventilators, it may be advisable to replace and re-insulate the existing piping and fin tubes here and throughout the building. [Much interior piping includes asbestos insulation that can be removed as part of a replacement project.]

Figure I-11: Existing finned tube radiation at perimeter walls.

- i. Quantity: Replace and insulate all hot water piping x 115,000 gross SF x \$5.00 to \$7.50 per SF = approximately \$575,000 to \$863,500.

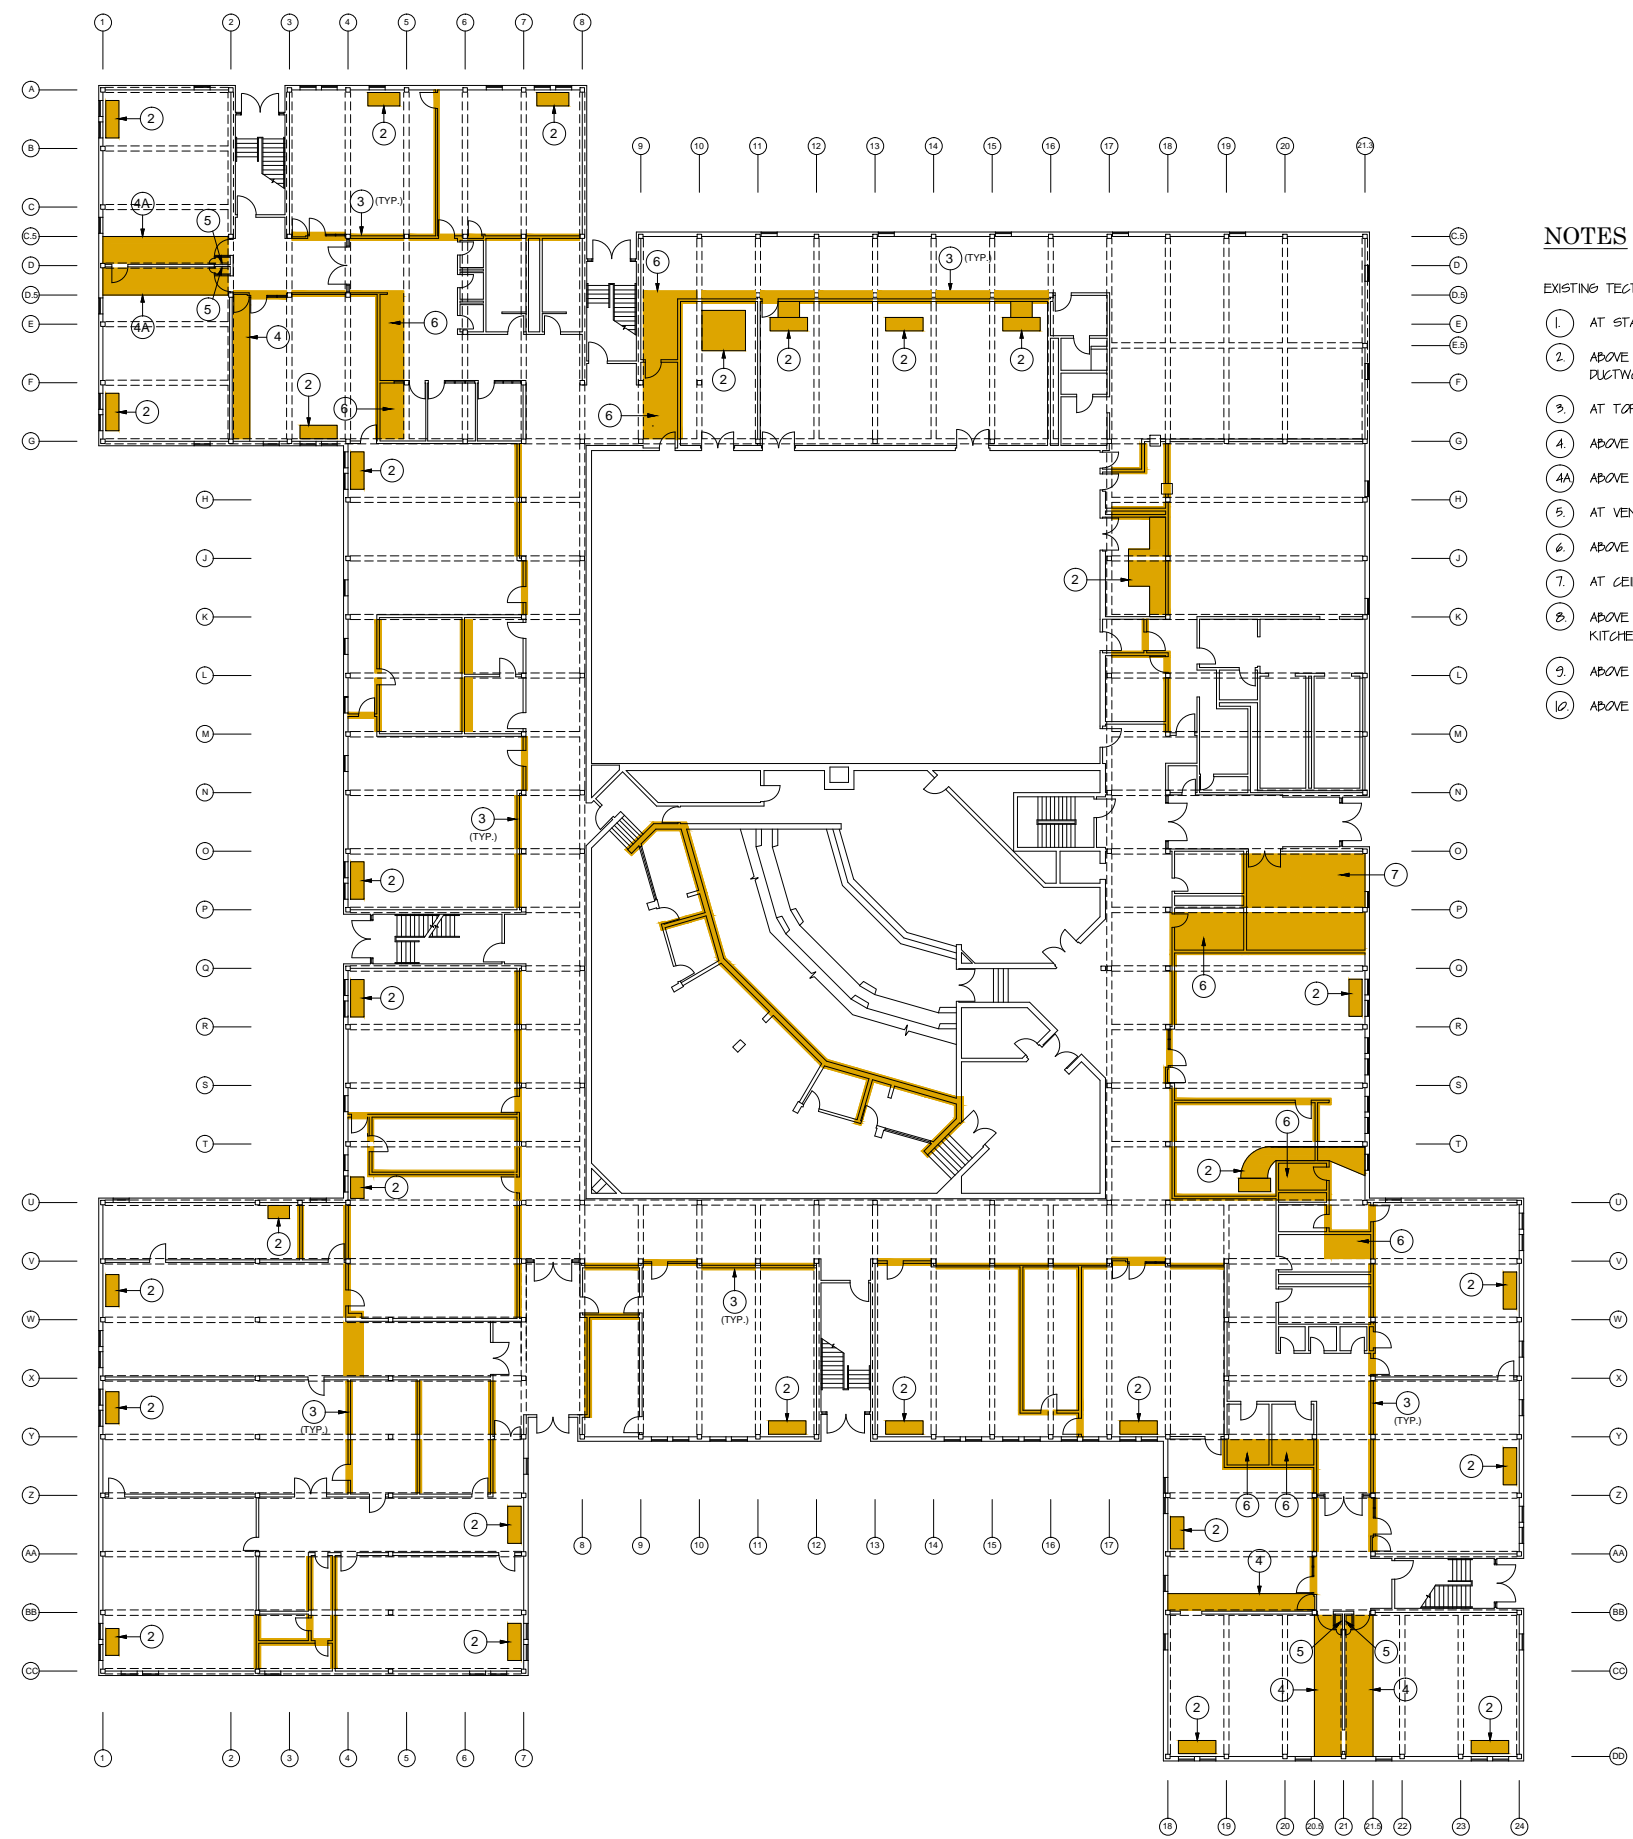
REMAINING
TECTUM
FORM PLANK

- EXISTING TECTUM FORM PLANK...
- 1. AT STAIRWAYS
 - 2. ABOVE EXISTING MECHANICAL EQUIPMENT & DUCTWORK
 - 3. AT TOPS OF PARTITION WALLS
 - 4. ABOVE SOFFIT AT MOVABLE PARTITION
 - 4A. ABOVE SOFFIT AT PARTITION
 - 5. AT VENTILATION CLOSET
 - 6. ABOVE SUSPENDED CEILING
 - 7. AT CEILING
 - 8. ABOVE SOFFIT / SUSPENDED CEILING AT KITCHEN (VIF.)
 - 9. ABOVE KITCHEN COOLERS & FREEZERS (VIF.)
 - 10. ABOVE SOFFIT AT TEACHER DINING.

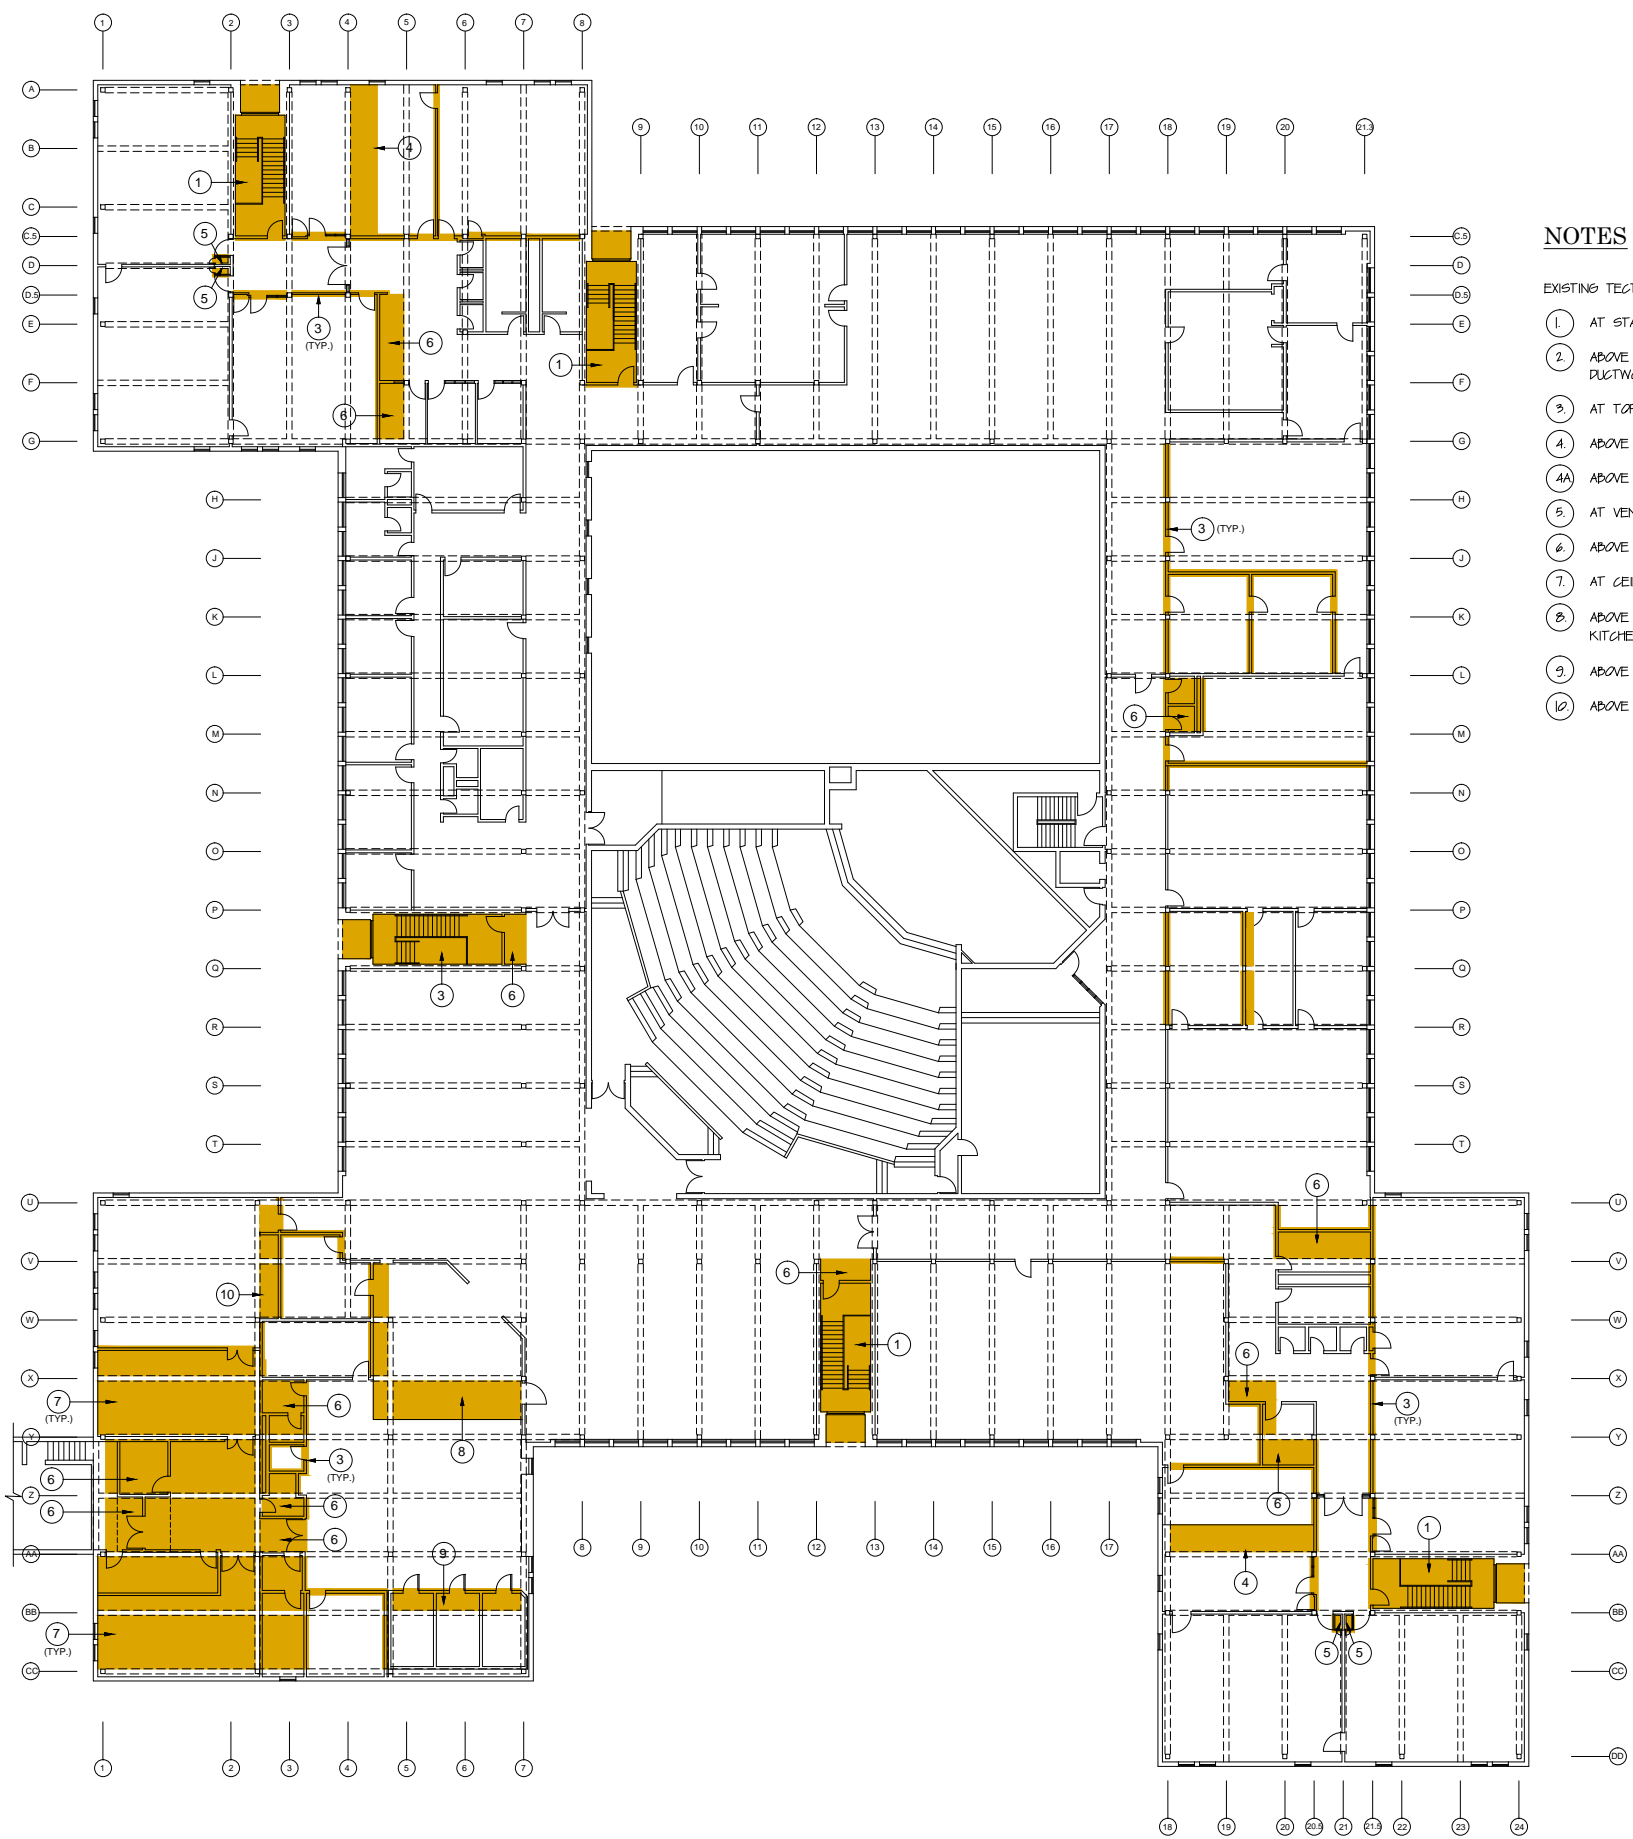
UPPER LEVEL:
REMAINING
TECTUM
FORM PLANK

EXISTING TECTUM FORM PLANK...

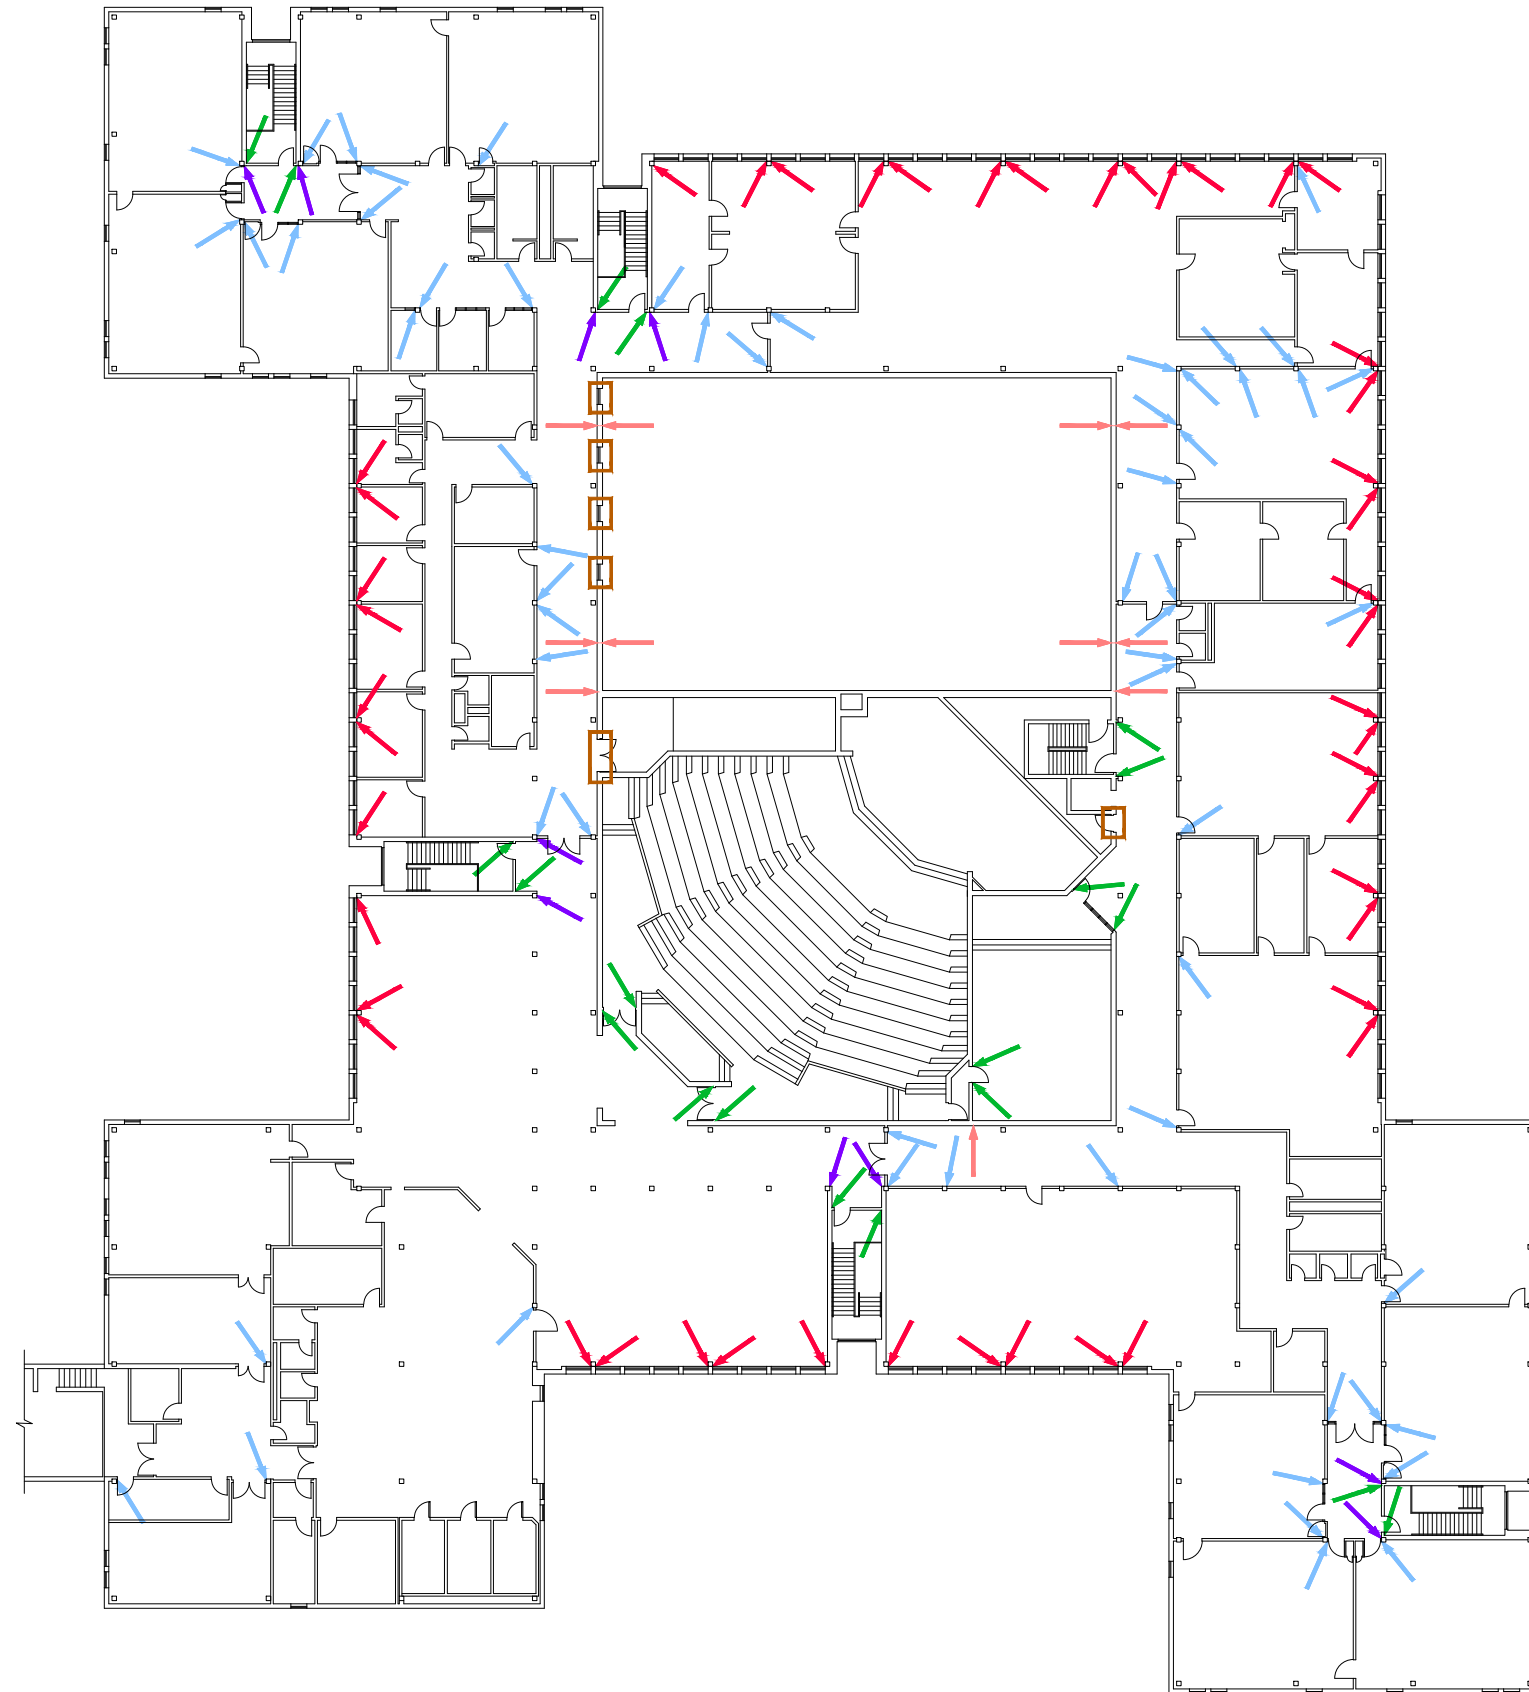
**UPPER LEVEL:
INTERIOR CAULK
JOINTS**

- JOINT AT BRICK TO CONCRETE AT STAIRWAYS
- JOINT AT BRICK TO CONCRETE AT WINDOW PIERS
- JOINT AT STEEL FRAMES TO BRICK VENEER
- JOINT AT STEEL FRAMES TO REINFORCED BRICK MASONRY WALLS
- JOINT AT STEEL FRAMES TO CONCRETE COLUMNS
- EXPANSION / CONTROL JOINTS IN REINFORCED BRICK MASONRY WALLS
